State of California
The Resources Agency
Department of Water Resources
Division of Environmental Services, Fish Facilities Section

A Pilot Study on the Bio-fouling Resistance of
304 and 316 Stainless Steels and Copper Nickel Metal.

July 28, 2005

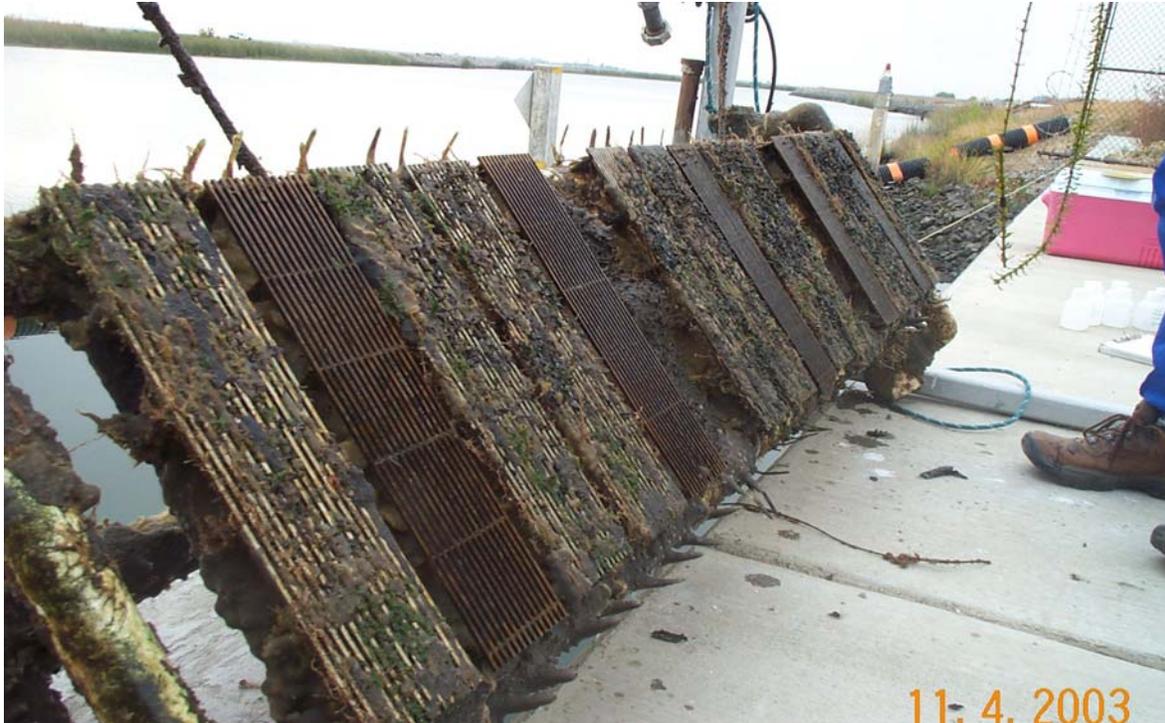
The 304 and 316 coupons did not perform as well as the CuNi coupons. Biofouling was observed on the 304 and 316 coupons for all sample intervals (Charts 2 and 3). The highest percent coverage occurred during the sampling interval of February 11, 2003 to May 27, 2003. This sample interval produced 100% coverage of the wedgewire surface face for both 304 and 316 coupons. The

coupons were 5% covered with sponge and 95 percent covered with a thin brown layer of algae. Although the coverage was very high during this interval, the open area occlusion was only 7%. The greatest percentage of open area occlusion occurred during the interval of May 27, 2003 through November 4, 2003. This interval produced 70% wedgewire face coverage and 60% open area occlusion (Figure 10). The high percentage of occlusion can be attributed to the large quantity of fresh water sponge on the coupons. This site consistently produced sponge growth on the coupons and visual inspections throughout the study indicate that the sponge first set hold on the wedgewire support members and then spread throughout the screen if given enough time. In the early stage of sponge establishing itself on the screens, it was found only on the wedgewire supports members. There was no visible difference in the amount of fouling between the 304 and 316 coupons. Light to moderate scrubbing with a plastic spatula and nylon brush was necessary to remove the biofouling from the coupons.

Figure 10. Los Vaqueros Biofouling for sample interval 5/27/03 – 11/4/03.

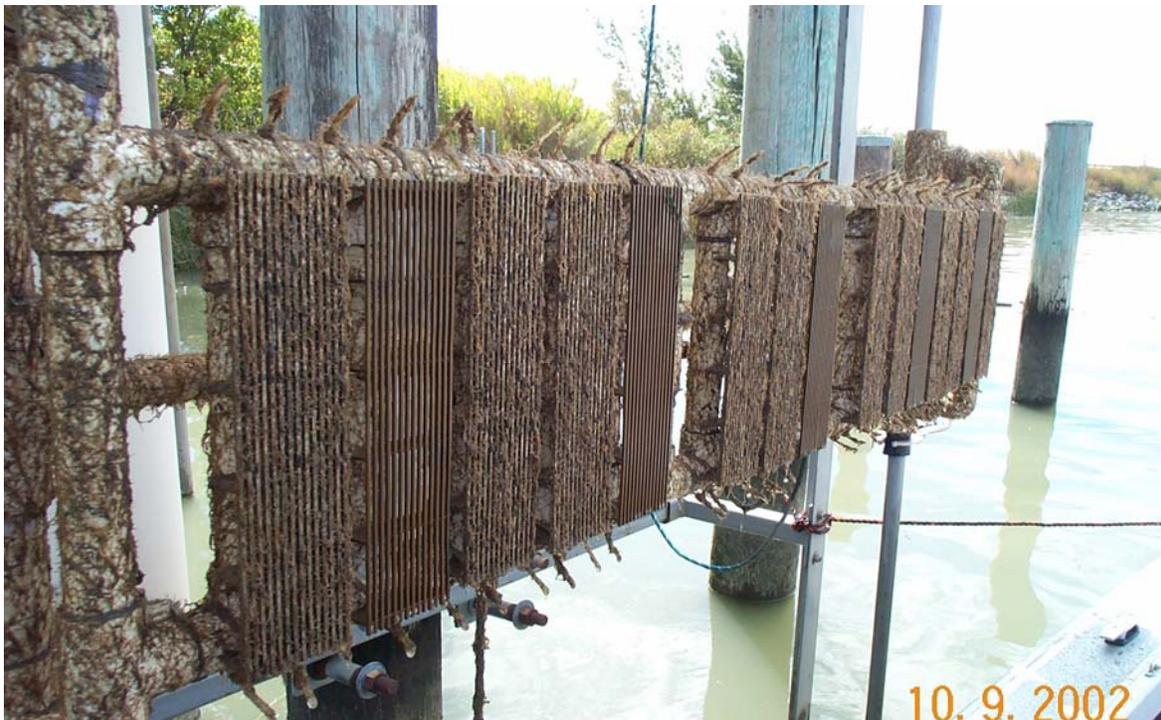
In contrast to the CuNi, for all intervals biofouling was present on the 304 and 316 coupons. The biofouling at this site was much more filamentous and embedded with silt when compared to the Los Vaqueros site. The highest wedgewire face coverage (95%) for the 304 and 316 coupons occurred during the sampling interval of August 1, 2002 through October 9, 2002 (Figure 11). The coverage consisted of filamentous brown algae embedded with silt. The filamentous alga appears to aid in the build-up of sediment on the coupons. This is evident from photos showing the CuNi wedgewire supports clean with no silt build-up, and the wedgewire supports on the 304 and 316 coupons with fibrous algae and heavy sediment build-up (see photos in appendix). The highest percentage (40%) of open area occlusion occurred during the sample interval of May 27, 2003 through October 9, 2003. The higher percent of open area occlusion is due to the presence of fresh water sponge on the coupons during this interval. It is the only sample interval at this site that produced fresh water sponge. Similar to the Los Vaqueros site, the sponge appears to have originated on the wedgewire supports. The lowest percent (20%) of wedge wire coverage occurred during the sampling interval of October 9, 2002 to December 6, 2002. Filamentous algae were the primary fouling source during this interval. Moderate scrubbing/scraping with a nylon brush and plastic spatula were necessary to remove the filamentous algae from the 304 and 316 coupons.

Figure 11. Horseshoe Bend biofouling for sample interval 8/1/02 – 10/9/02.

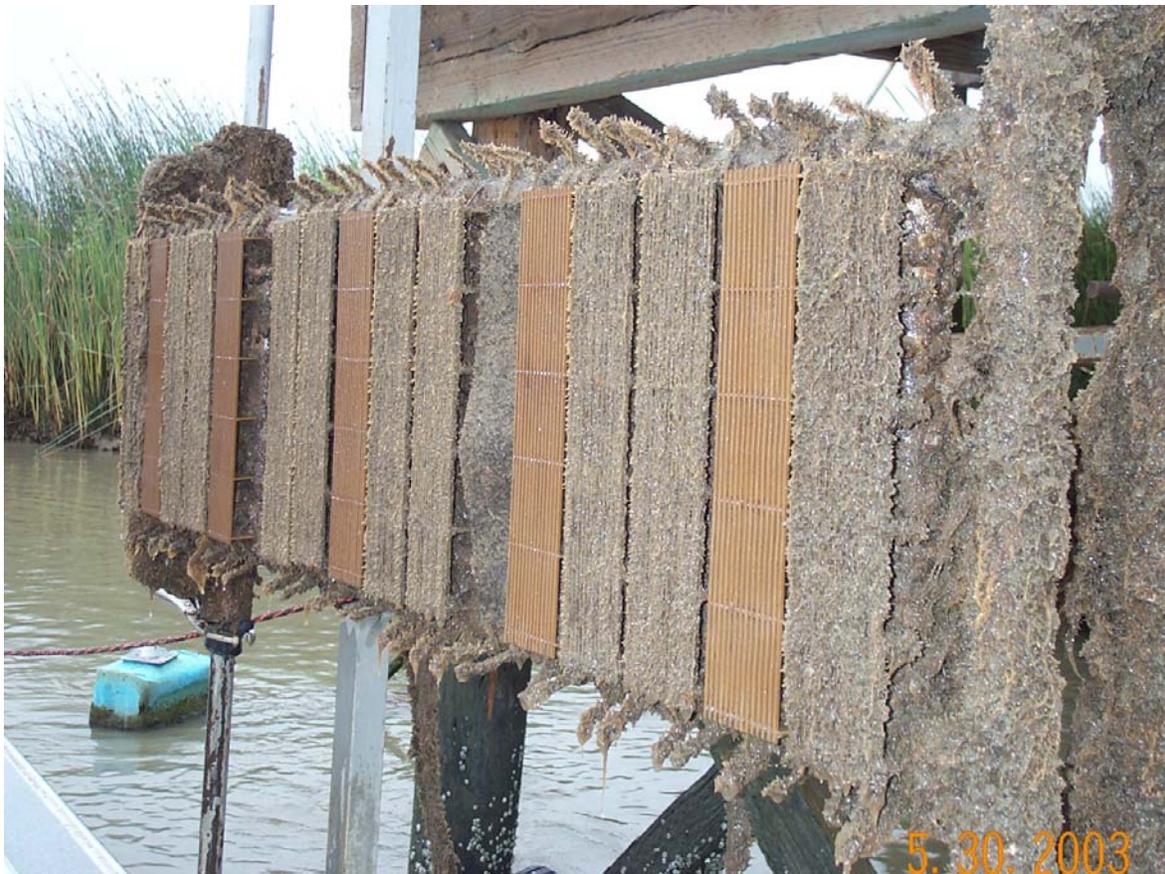
For all sample intervals, biofouling was present on the 304 and 316 coupons (Charts 8 and 9). The primary biofouling agents at this site were barnacles and calcareous algae. Most of the barnacles on the screen coupons were attached to the wedgewire supports with only a few attaching to the wedgewire itself. The prevalence of the barnacles on the wedgewire supports could be in part due to larger surface area that is provided by the supports. At this site two intervals, February 7, 2003 through May 30, 2003 and May 30, 2003 through September 25, 2003, produced 100% coverage of the wedgewire surface face. The type of biofouling was very different for both sample intervals. The sample interval of February 7th through May 30th of 2003 produced a web of algae and heavy sediment that covered the 304 and 316 screen coupons (Figure 12). Some barnacles were found attached to the wedgewire under the web of algae. This sample interval also had the highest percentage of open area occlusion at 70%. The very dense web of biofouling blocked the majority of the open area on some of the 304 and 316 coupons. For the sample interval of May 30th through September 25th of 2003, the 304 and 316 coupons were covered with calcareous algae and some barnacles, the same type of biofouling produced during the other sample intervals. Although this interval also had 100% wedgewire face coverage,

the biofouling only produced a 15% occlusion of the 304 and 316 coupon open area. The 304 and 316 coupons required heavy scraping/scrubbing with plastic spatulas and nylon brushes to remove the biofouling.

Figure 12. Morrow Island Biofouling for sample interval 2/7/03 – 5/30/03.

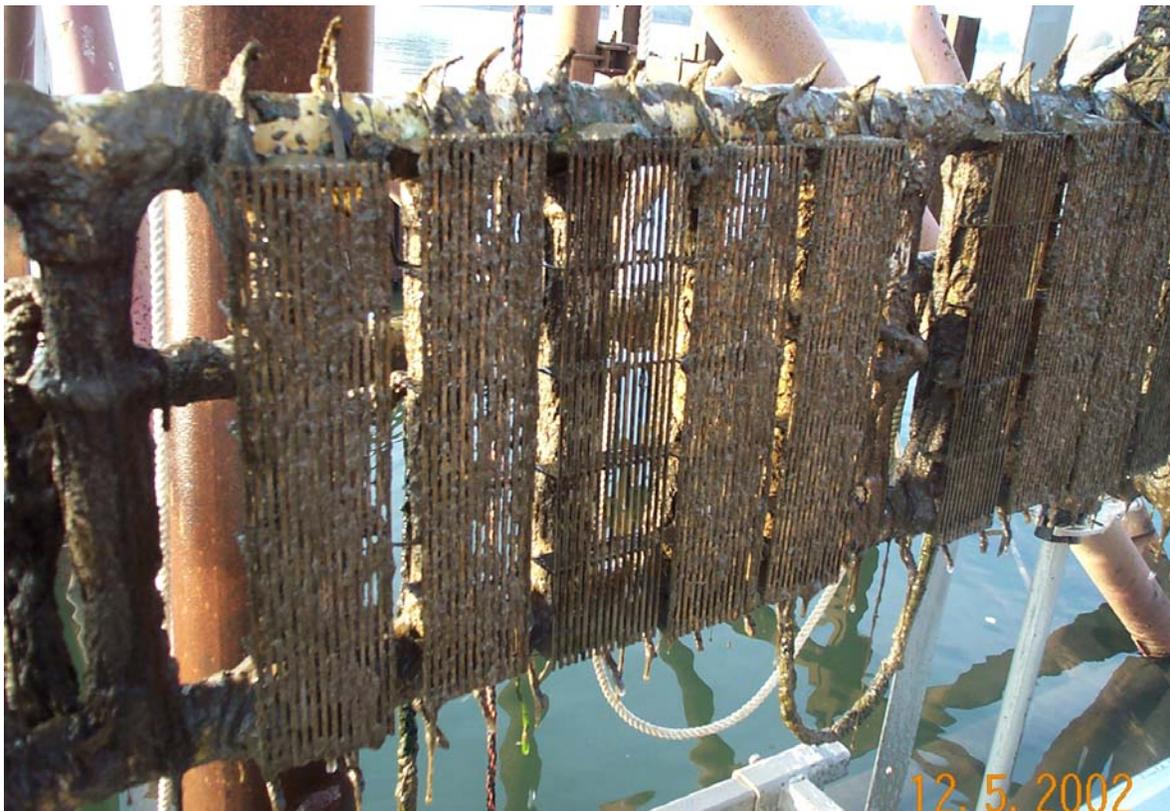
off of the CuNi coupons. Qualitative analysis of the material from all three metals revealed similar biofouling species (see taxonomic tables). The CuNi coupons were stained a dark brown early in the study. It is unknown what caused the staining, and unclear whether it promoted biofouling by inhibiting the CuNi from forming its protective anti-biofouling patina. The coupon open area occlusion caused by the CuNi biofouling was minimal (1%) for all sample intervals. Floating debris such as twigs and grasses were consistently present on all coupons.

All sample intervals produced a high percentage of wedgewire surface face coverage on the 304 and 316 coupons. A total of three intervals produced 90% wedgewire surface face coverage on the 304 and 316 coupons (Charts 10-11). The gelatinous mixture of biofouling was very dense and blocked 50% of the 304 and 316 coupon open area for the interval of August 6, 2002 to October 7, 2002. The second highest percent (40%) of open area occlusion occurred during the interval of October, 7, 2002 through December 5, 2002. Floating debris such as grasses and twigs were consistently present on all coupons, including the CuNi coupons. The heavy silt load and how it accumulates on the screens can be seen in Figure 13. The coupons during the intervals that produced the lowest percent coverage had area with a thin layer of green algae and floating debris (twigs, grasses, leaves,). Floating debris was consistently present on all the coupons at this site. This is a site that had very high silt content, which is evident from the photos taken at the site that show heavy silt buildup on the coupons. The 304 and 316 coupons required moderate scrubbing with a nylon brush to remove the material.

Figure 13. Hood Site - Biofouling for sample interval 10/7/02 – 12/5/02.

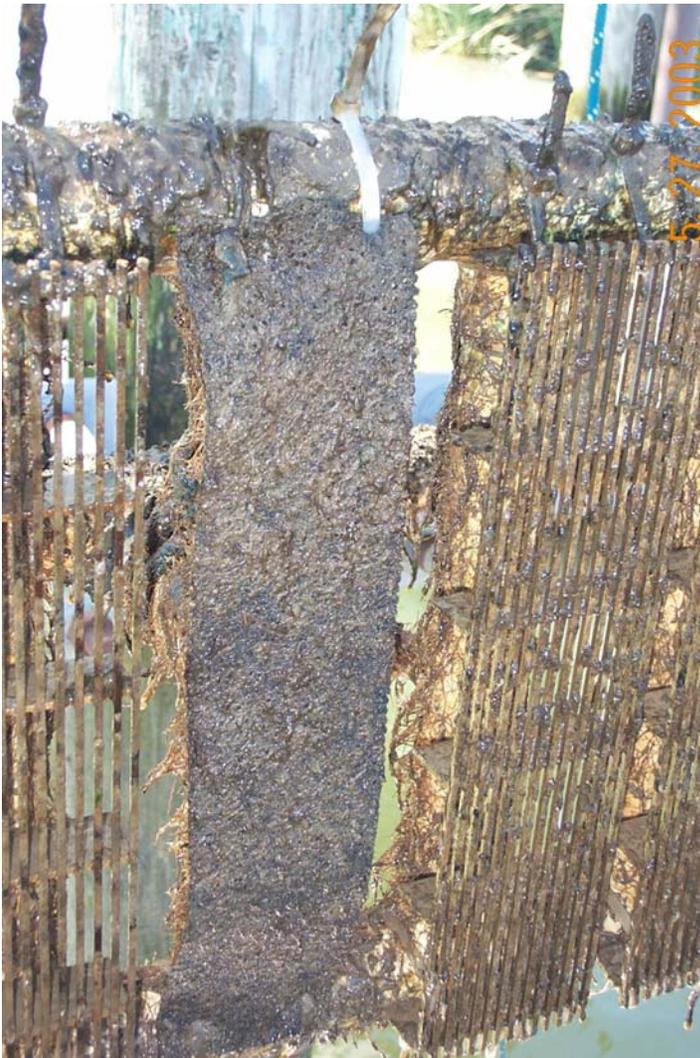
The fabric material was installed midway through the study (Figure 14) and was subjected to two sample intervals, which were the last and longest intervals of the study. The fabric was cut into sections with the same dimensions as the metal coupons, and one section was installed per site. Similar to the 304 and 316 coupons, the fabric had biofouling on all sample intervals at all the sites. Barnacles were the only organism found on the 304 and 316 coupons that were not observed on the fabric. We found the fabric easier to clean than the 304 and 316 coupons. Most of the biofouling came off by vigorously shaking the fabric under water.

Figure 14. Fouling on fabric material.

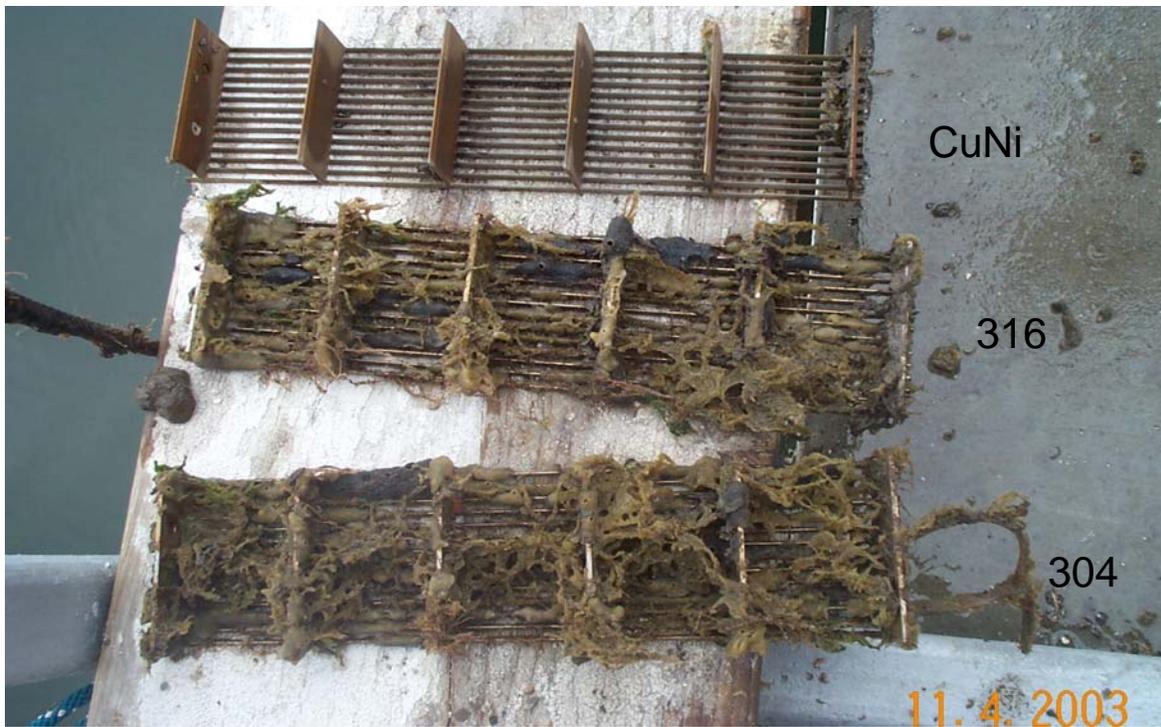
All coupons were installed with the orientation of the wedgewire in the vertical direction. This orientation placed the wedgewire support members in the horizontal direction. Observations indicate that the larger horizontal surface area of these wedgewire supports provided an area ideal for biofouling on the stainless steel coupons and is the area where barnacles, fresh water sponge and filamentous algae first set in. This area around the wedgewire supports (backside of screen coupons) consistently had larger amounts of biofouling material (Figure 13). It is unknown if positioning the wedgewire horizontally (support members vertically), would produce the same biofouling results. The larger surface area and not the orientation of the wedgewire supports may be what is facilitating more biofouling.

Figure 15. Photo shows Backside of Coupons at the Los Vaqueros site prior to cleaning. The CuNi coupon is free of biofouling after being in the water for five months. (Sample interval from 5/27/03 – 11/4/03)

Current cylindrical and flat plate screen cleaning technologies such as water pressure and rotating nylon brushes do not address control or removal of backside biofouling. Internal Water pressure systems do not provide the force needed to remove the material and rotating nylon brush systems only clean the face of the screen. As a result, constant maintenance and manual cleaning of some facilities is needed to address the problem. The study clearly shows an advantage to using CuNi over stainless steel to resist biofouling. It is a more expensive material, but its biofouling resistance could substantially reduce costs associated with maintenance, downtime and reduced system efficiency, potentially offsetting the initial higher cost of the material. The figure below (Figure 14) further supports considering the use of CuNi for building or retrofitting screen facilities.
