# Delta Levee Programs

# Local Flood Control Nonproject Levees

# Federal Flood Control Project Levees

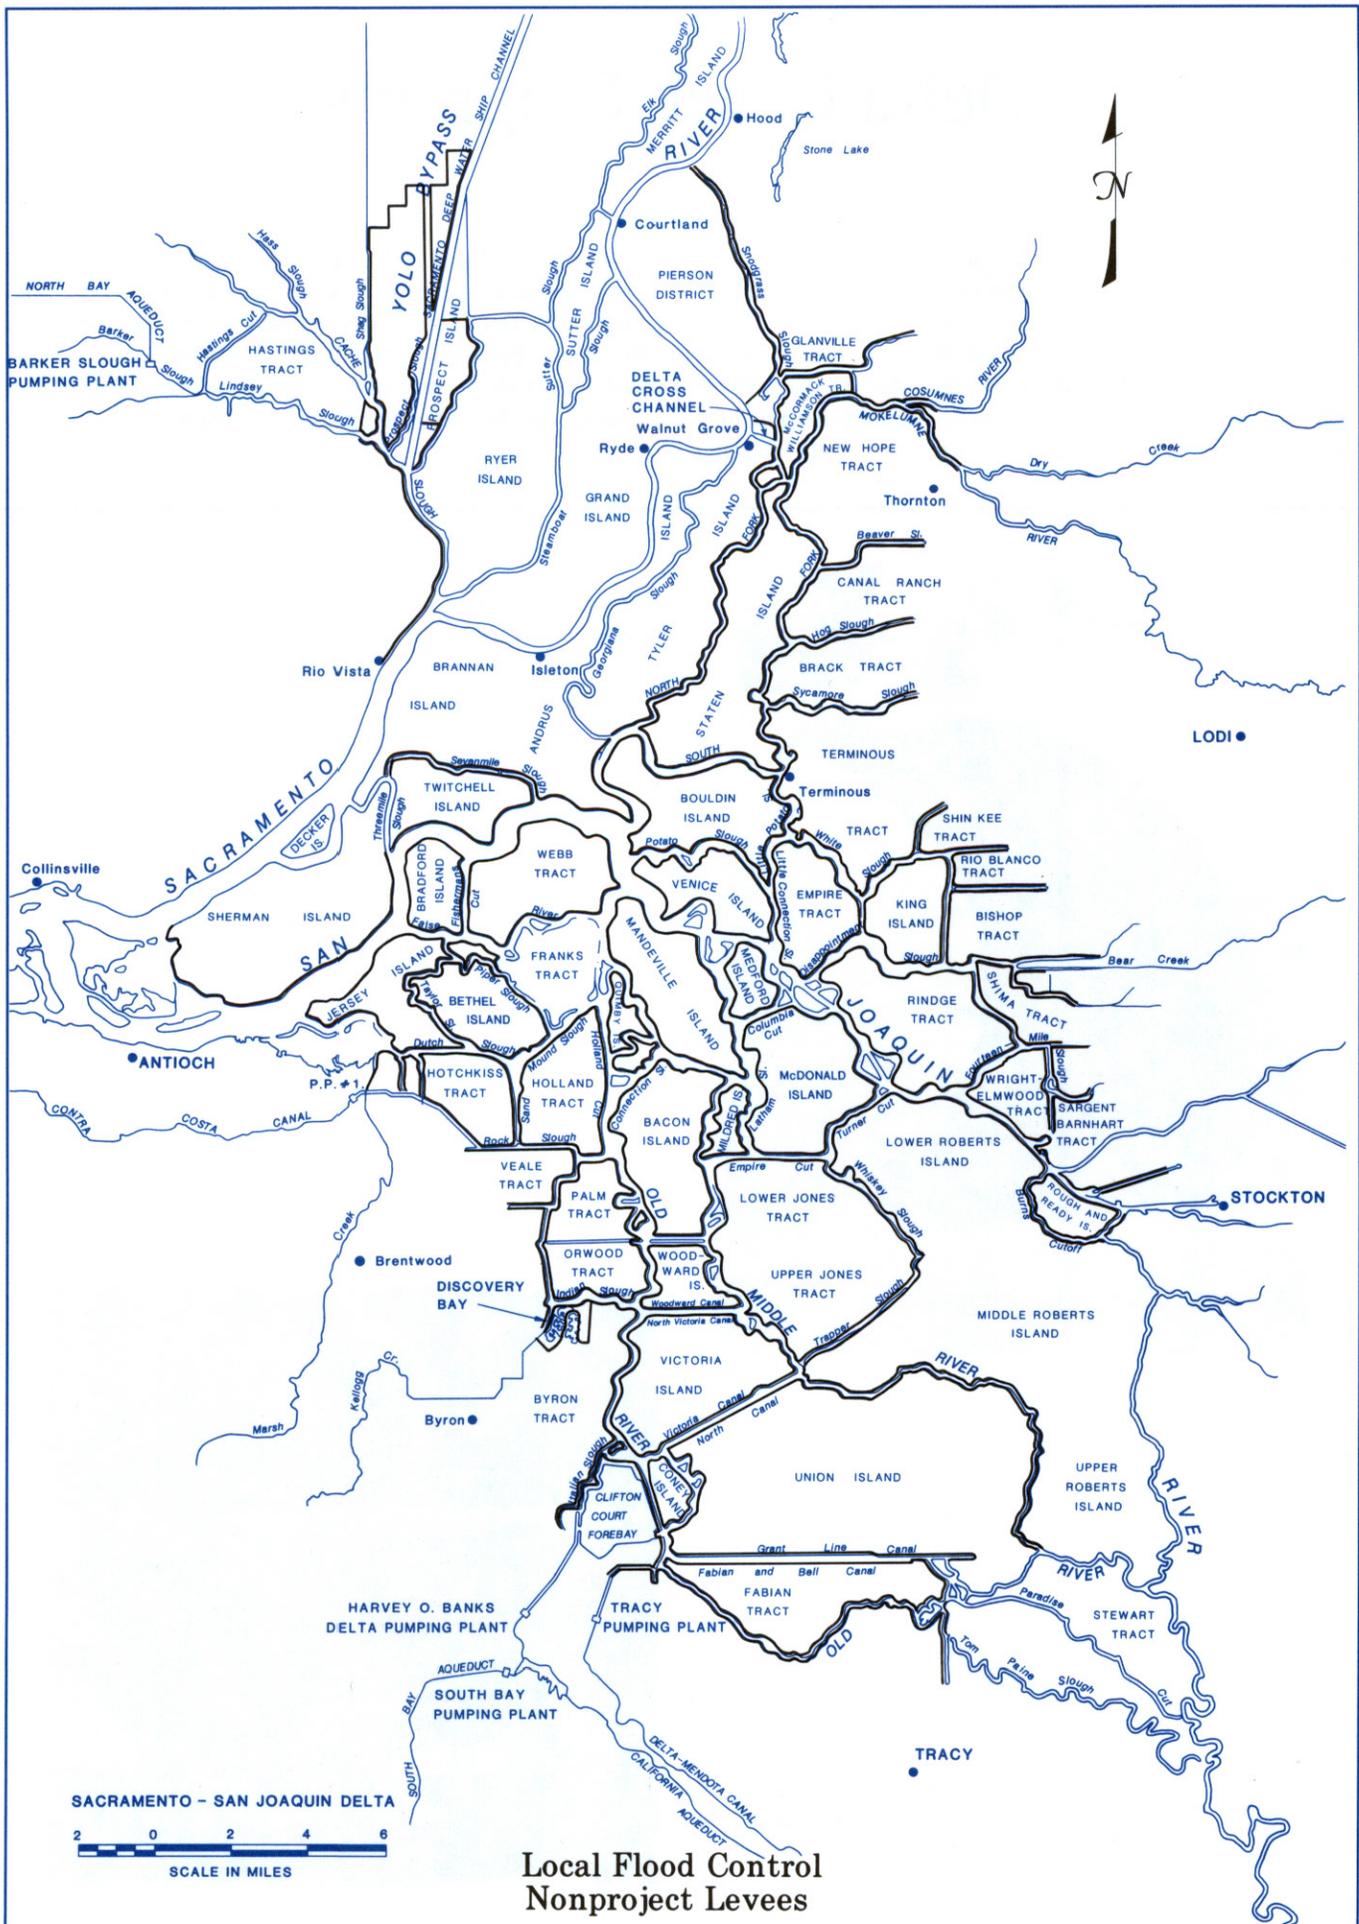
Most of the Delta lowlands are protected by nonproject levees as shown on the map at left. “Nonproject” distinguishes these levees from those that are part of federal flood control projects (see the following section). Improvement and maintenance of nonproject levees is very challenging because of poor foundations and regulations to protect levee wildlife habitat. Local districts responsible for maintaining these levees are reimbursed for a

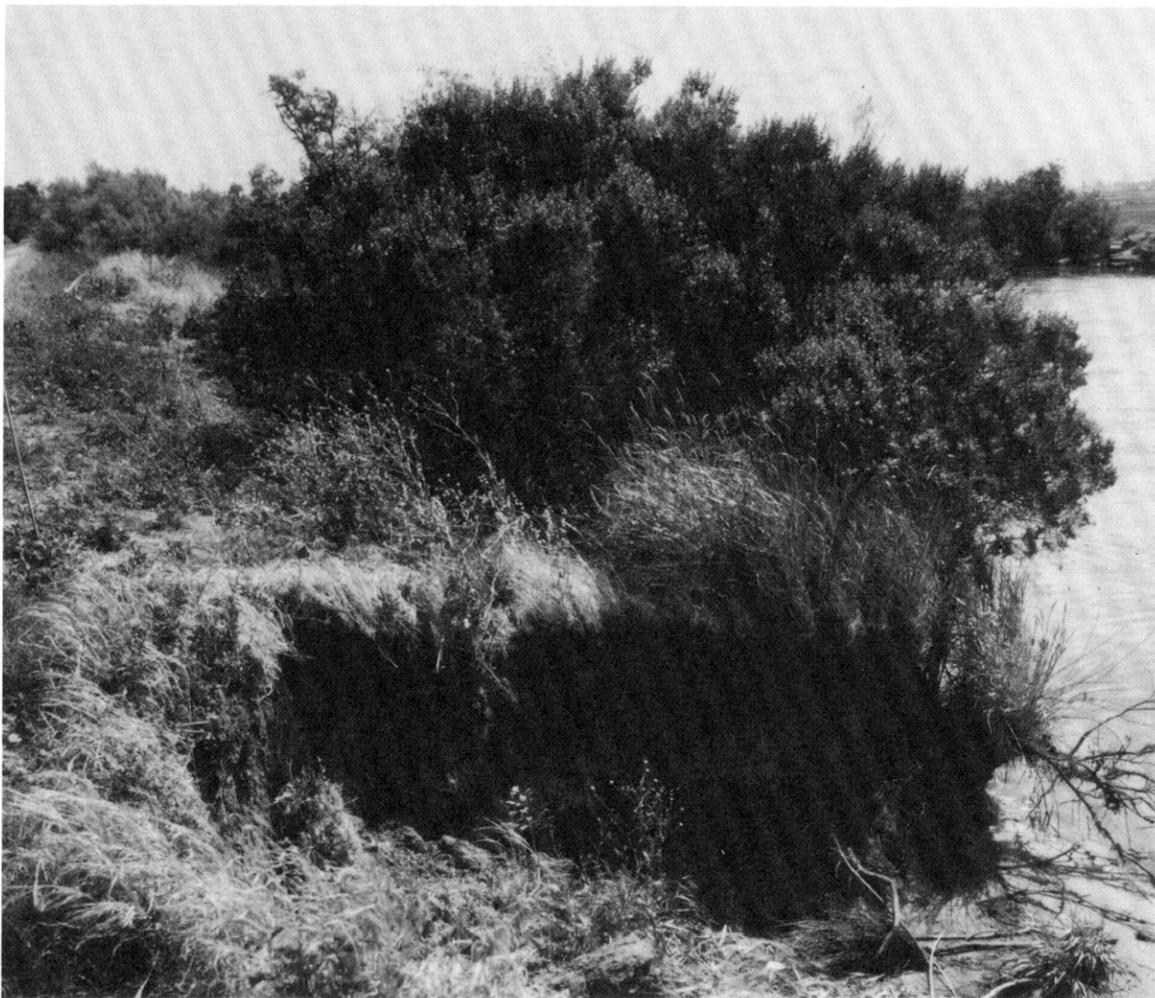
*Eroded nonproject levee protecting hundreds of acres of agricultural land and wildlife habitat.*

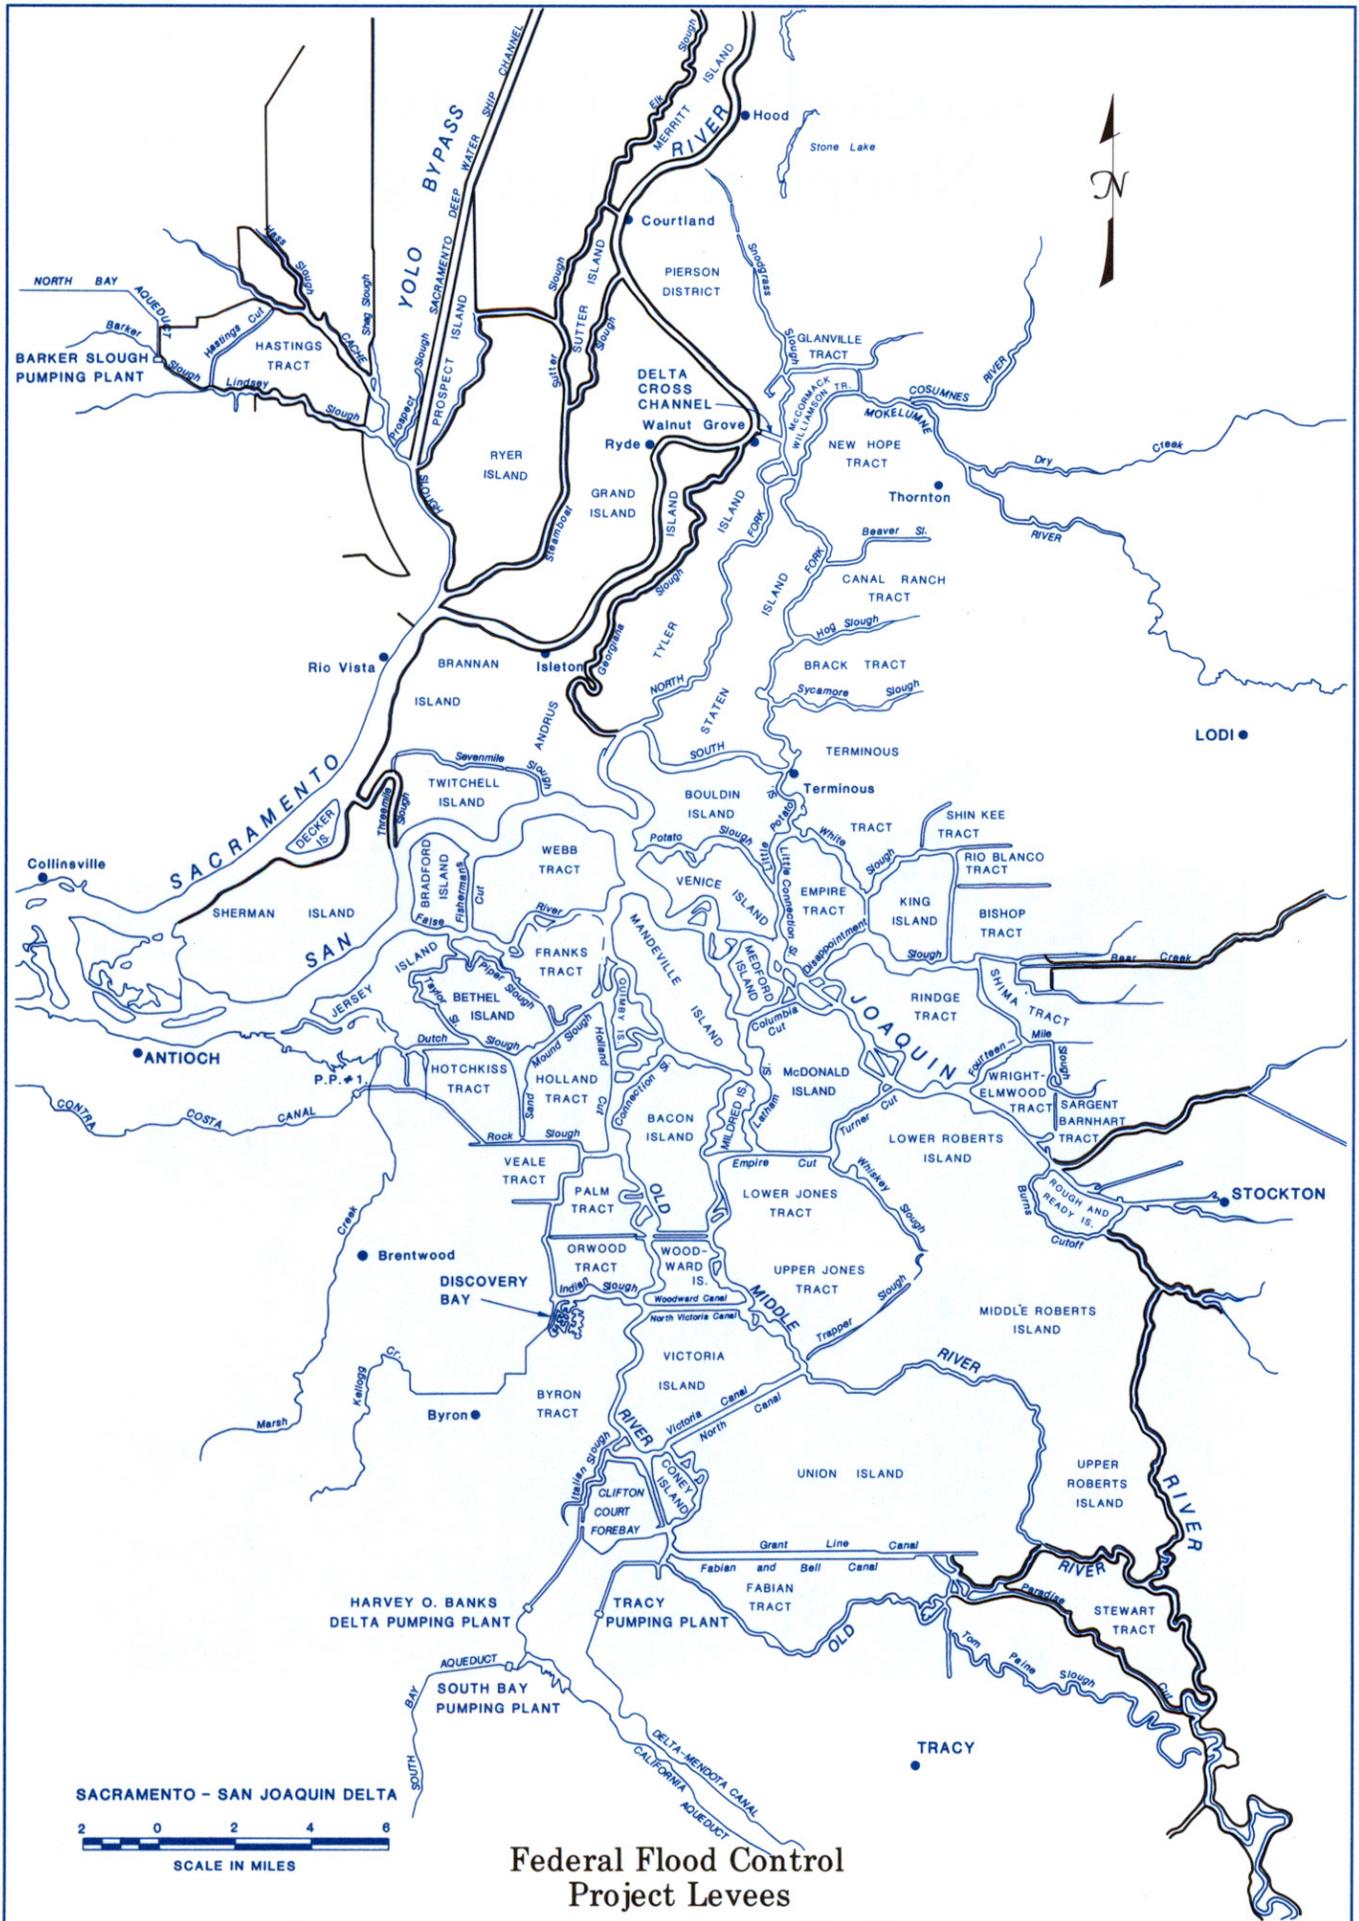
of Engineers in 1960. Storage reservoirs and similar protective measures have been provided on the San Joaquin River. As shown on the map at left, these systems, denoted “project levees” to distinguish them from other levees, provide effective flood control for a portion of the Delta.

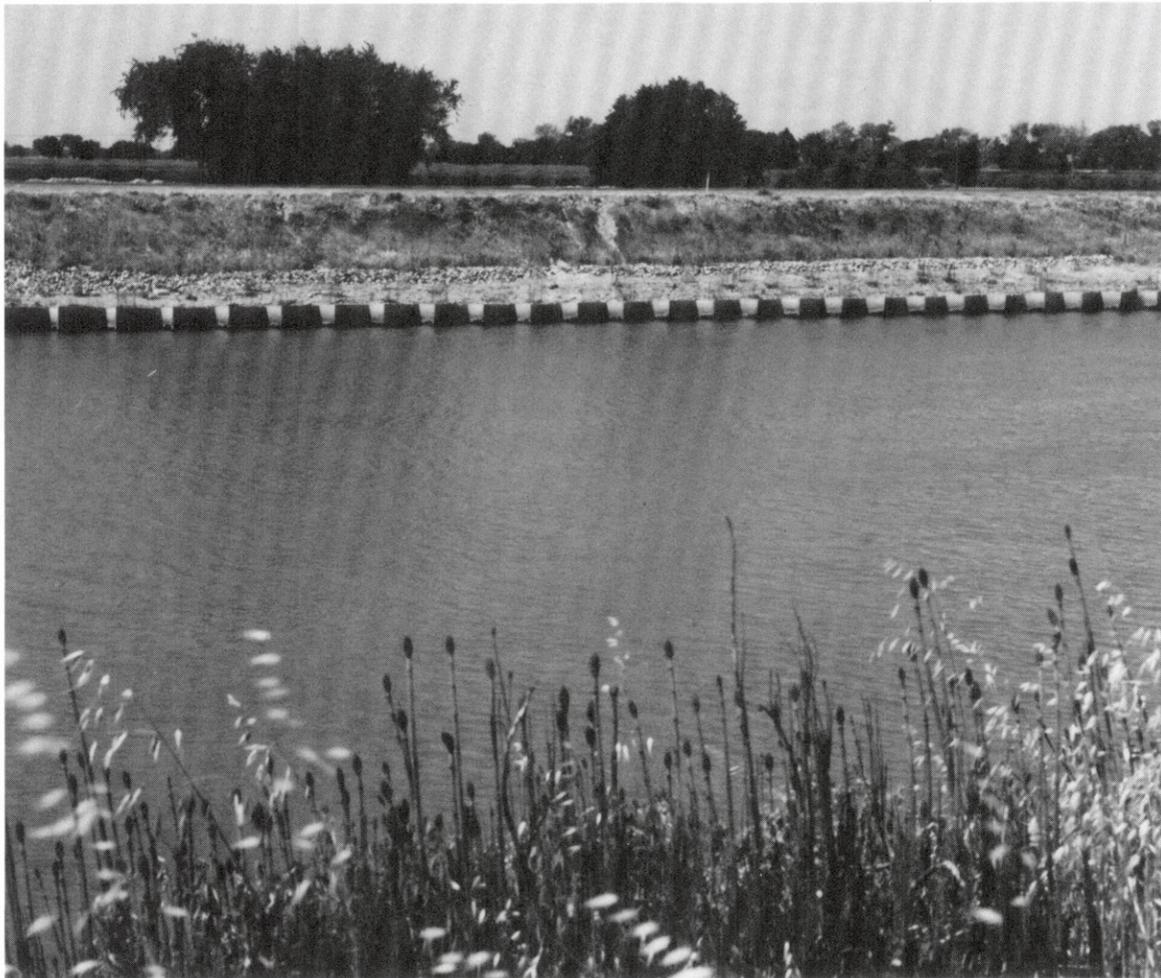
*Experimental levee maintenance programs are being conducted at various locations in the Delta to determine better ways to protect the environment while maintaining proper safety for flood control. This photo shows a project to develop a berm that will provide for environmentally important shaded aquatic habitat.*

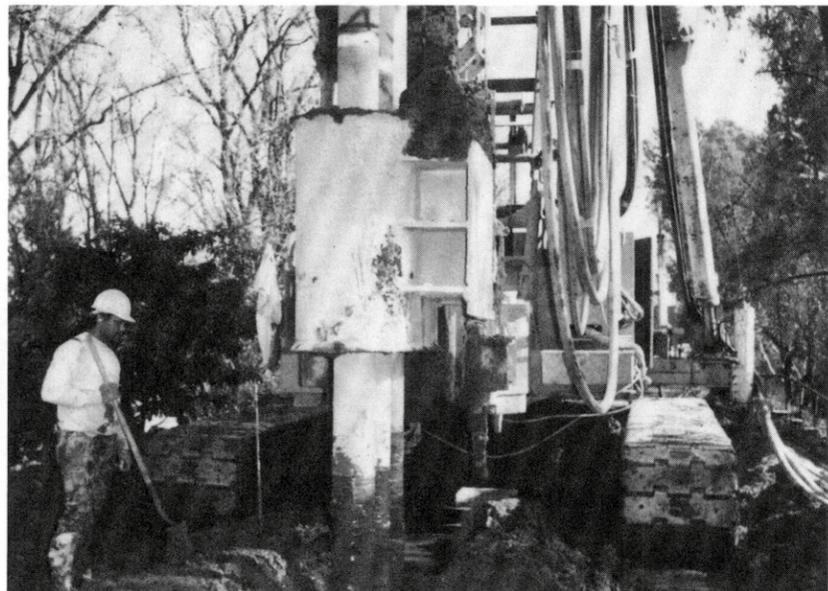
*The U.S. Army Corps of Engineers working to increase the strength of project levees along the Sacramento River.*

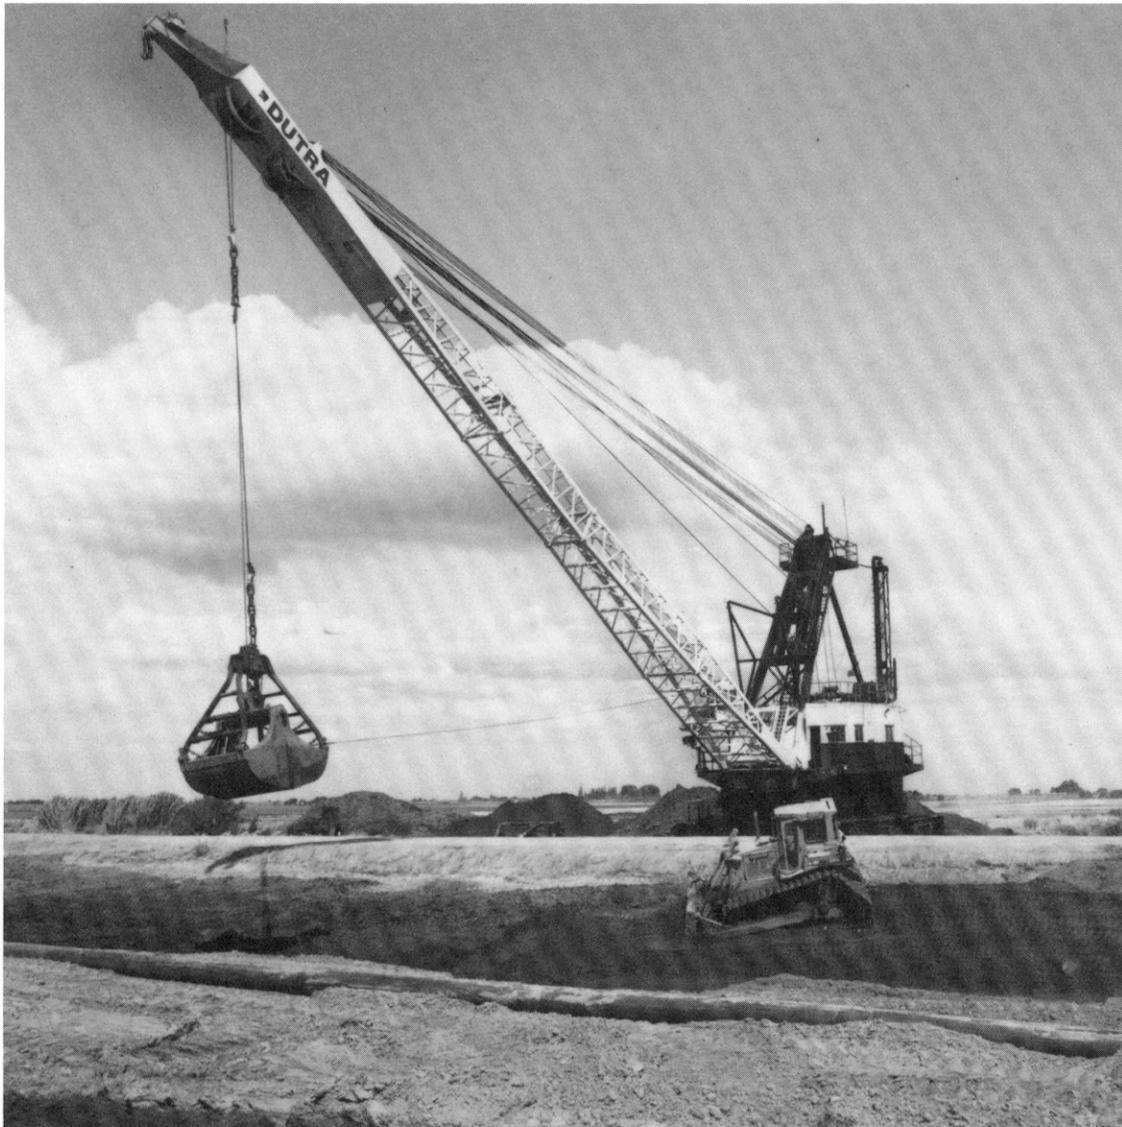
*Levee rehabilitation on Twitchell Island.*

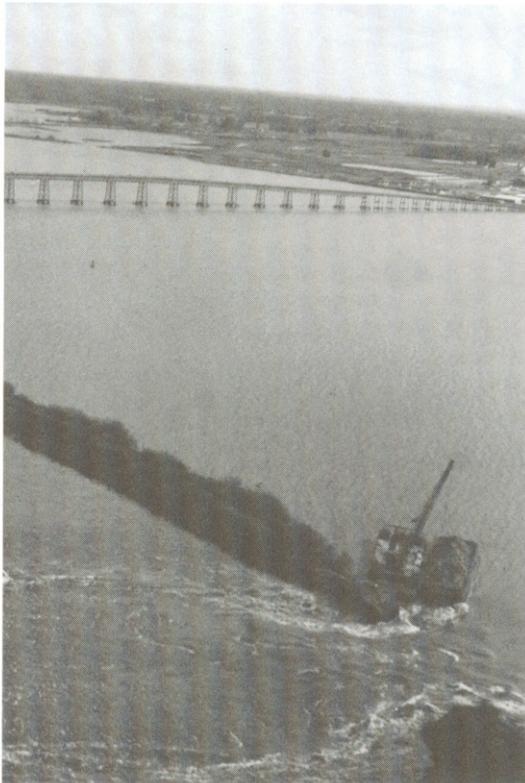
*Levee break on  
Sherman Island in 1969.*

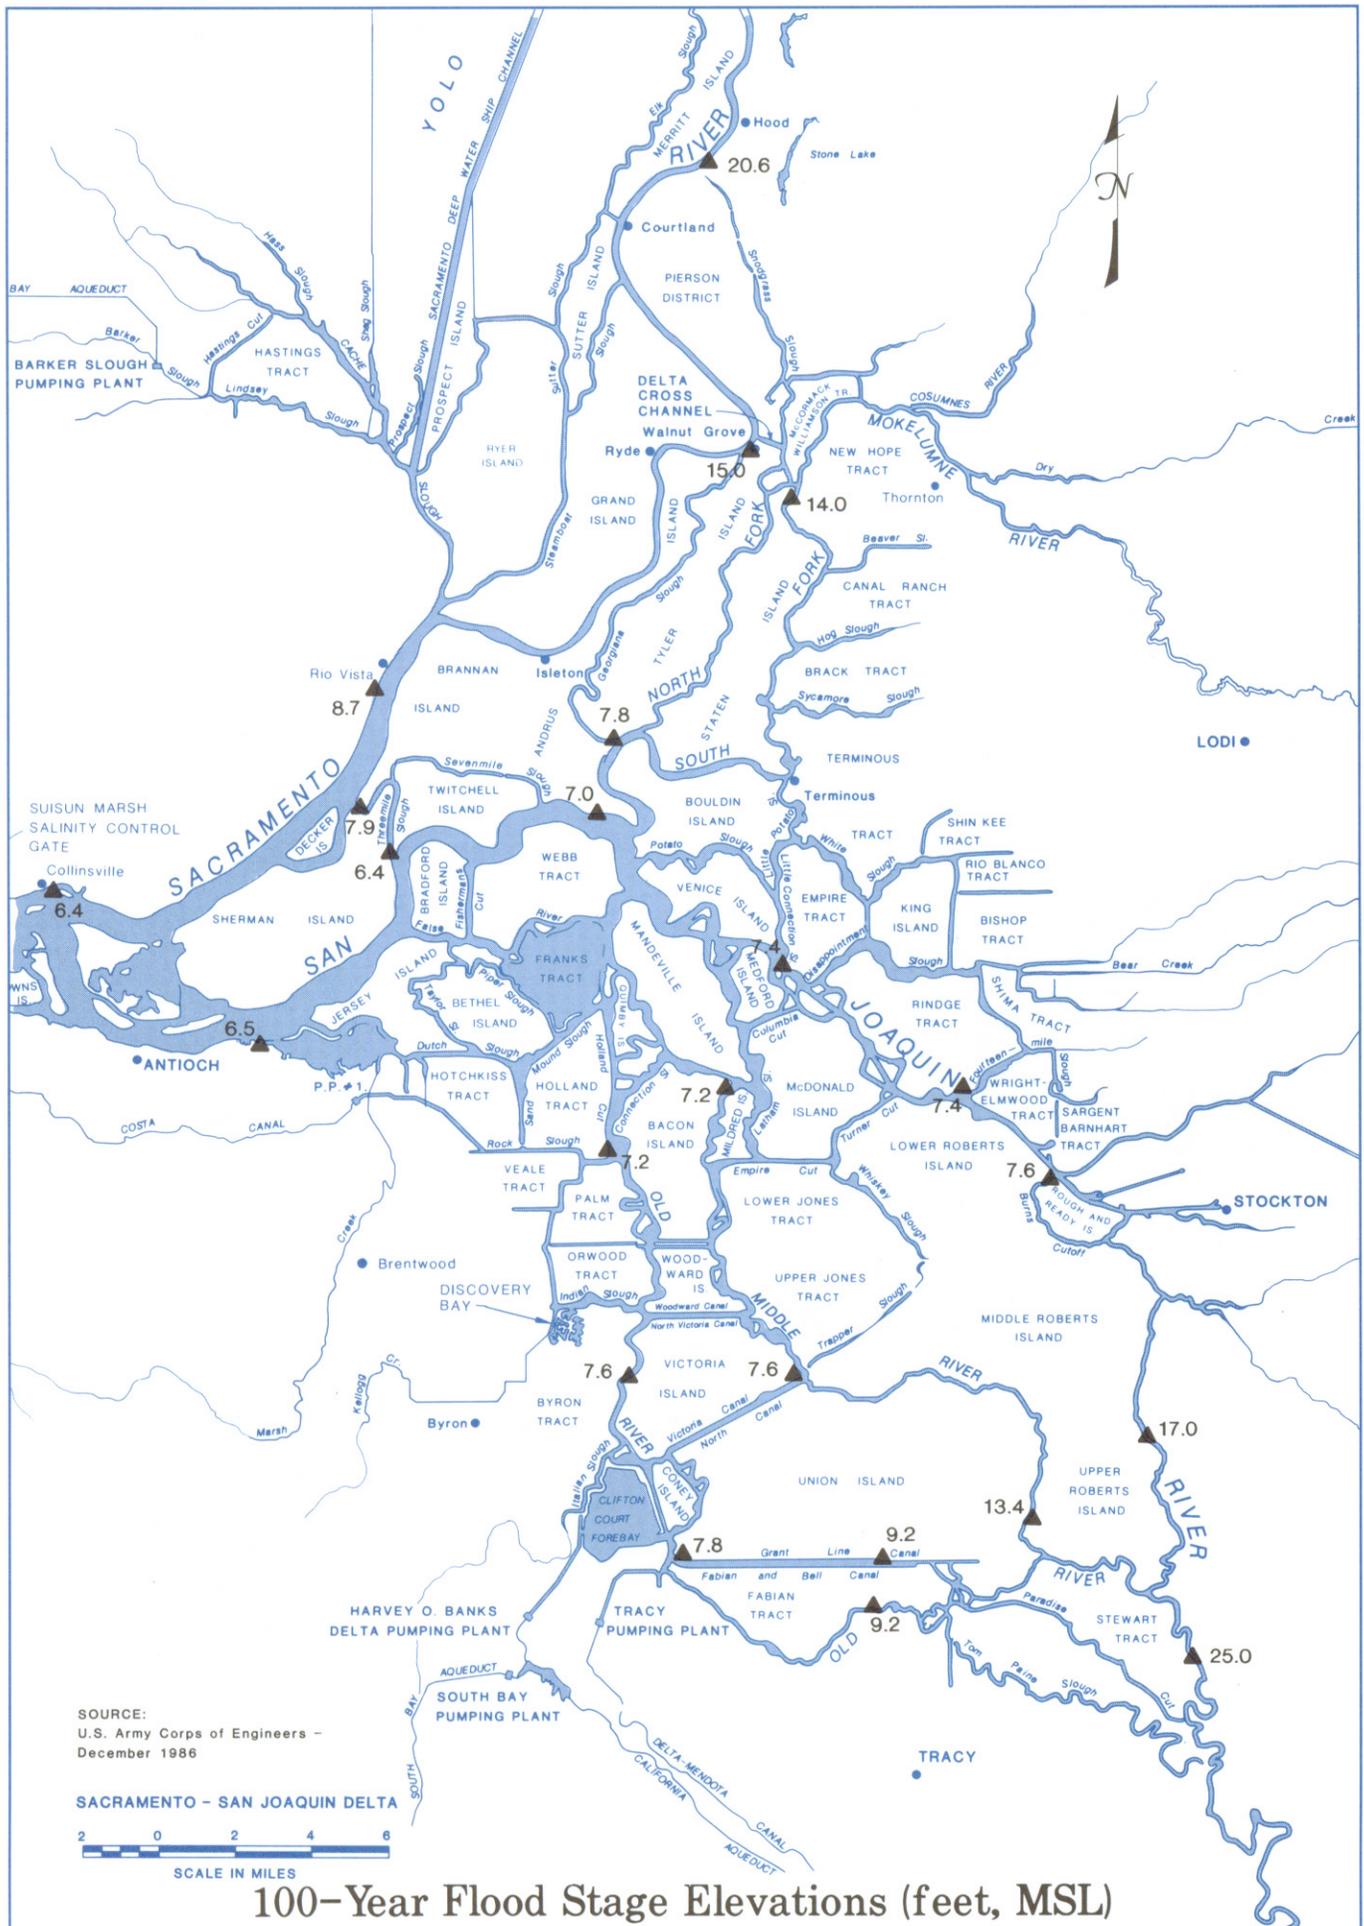
capacity of the channels, has occurred in various places throughout the Delta, particularly along the South Fork of the Mokelumne River. In 1986, the U. S. Army Corps of Engineers estimated the 100-year flood stages to be as shown on the map at left.

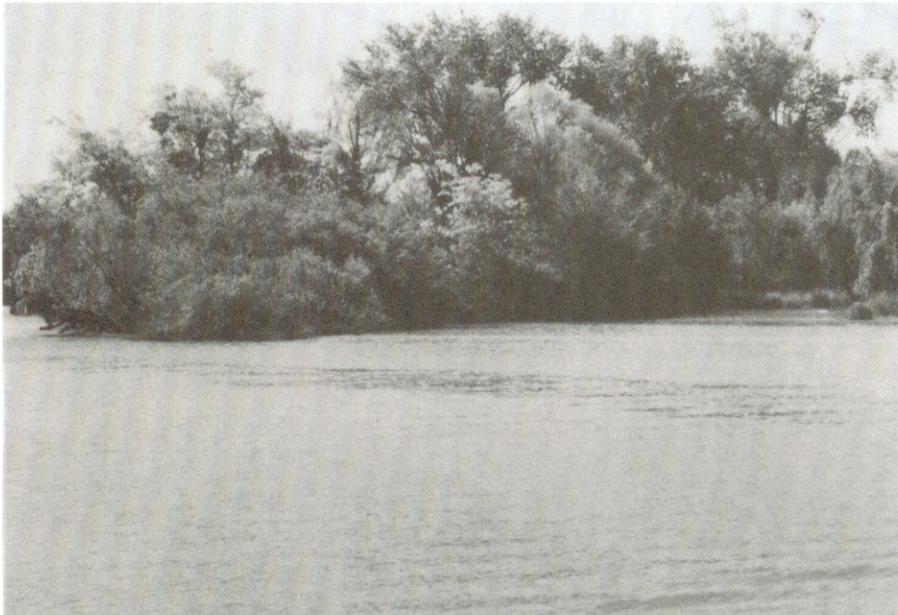
*Sedimentation in the Mokelumne River encourages vegetative growth which limits flood-carrying capacity.*

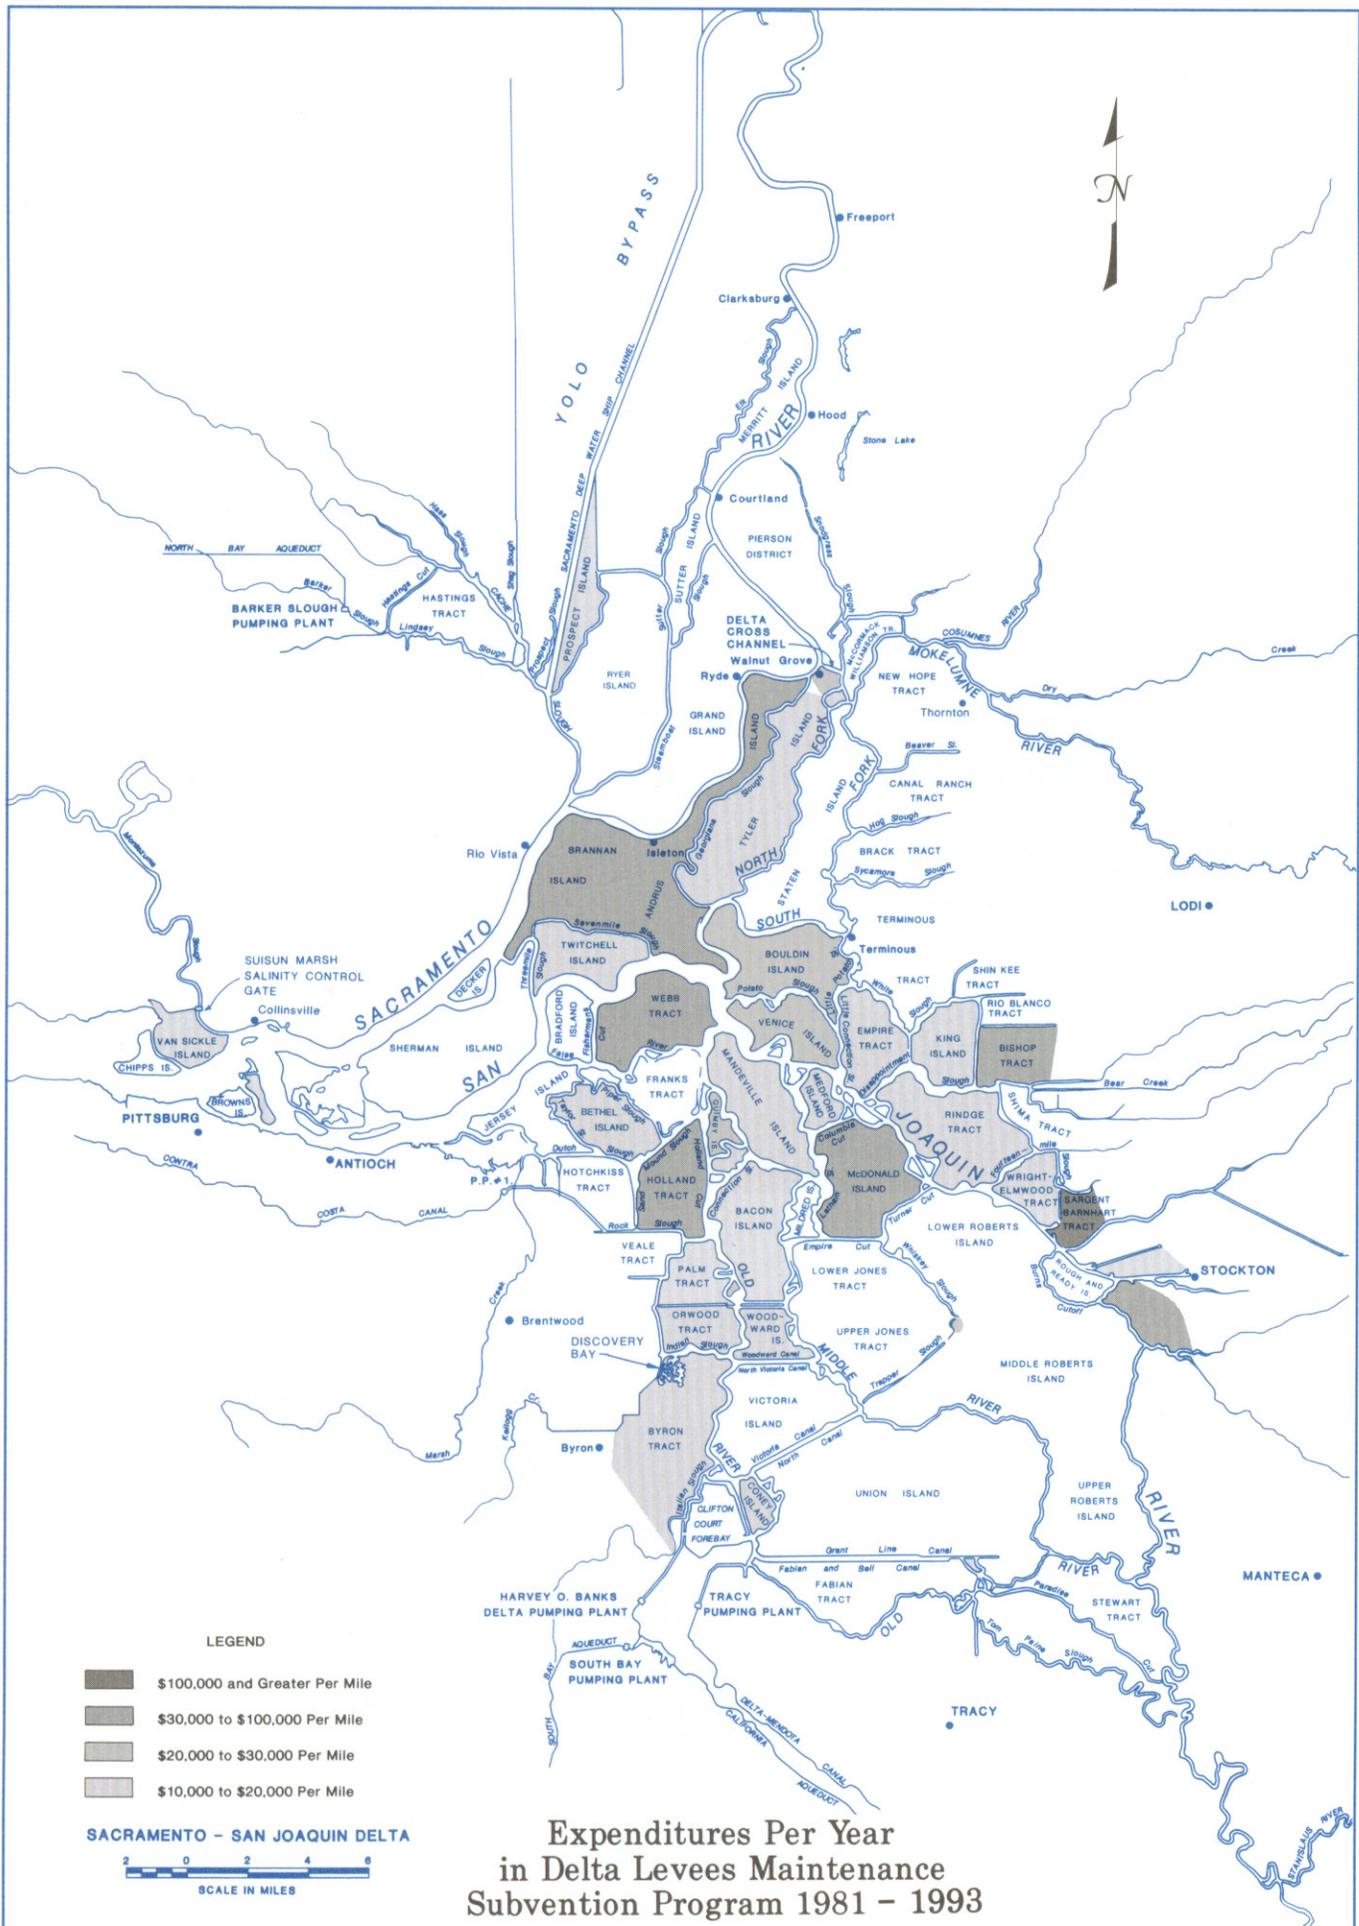
value of the island or tract being protected. The map at left shows the average amount of State money spent per year of participation in the State cost-sharing program (Delta Levees Maintenance Subvention Program) for the period 1981-1991. This, along with other related information, is contained in Table 2 on page 83.

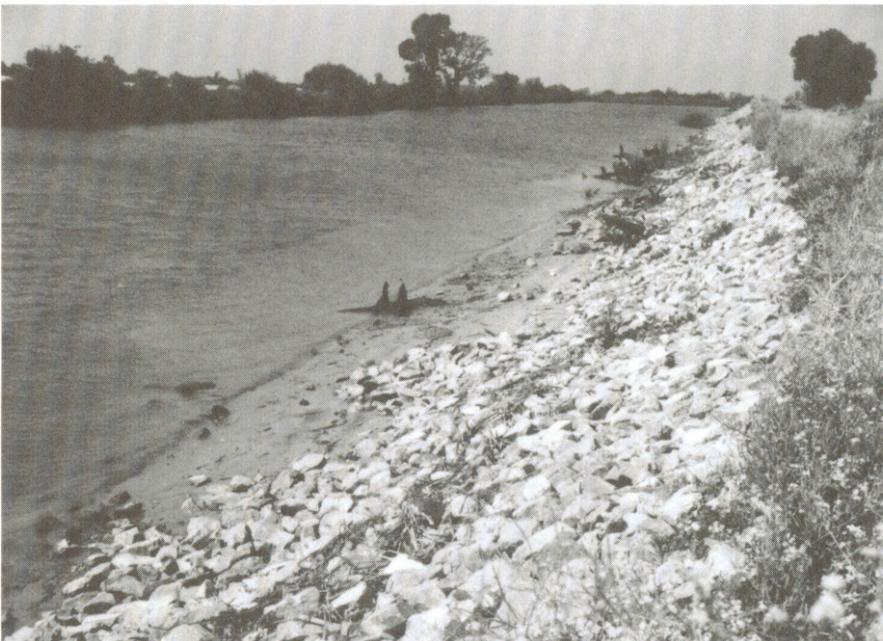
*Some levees are protected from erosion by riprap.*

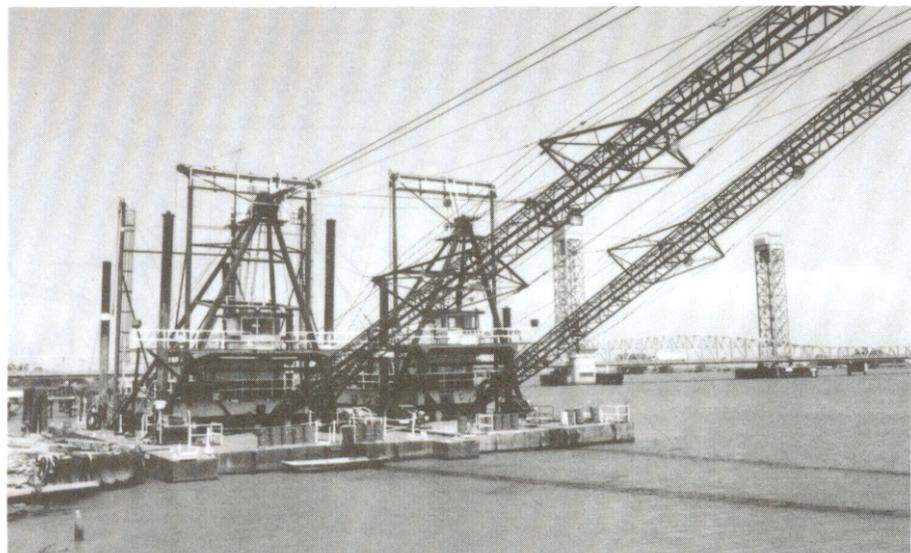
*Typical barge-mounted crane used for levee maintenance.*
