# **DSM2 Analysis of Water Level and Water Quality in the South Delta**

**Presented to  
DSM2 Users Group**

**November 2, 2006**

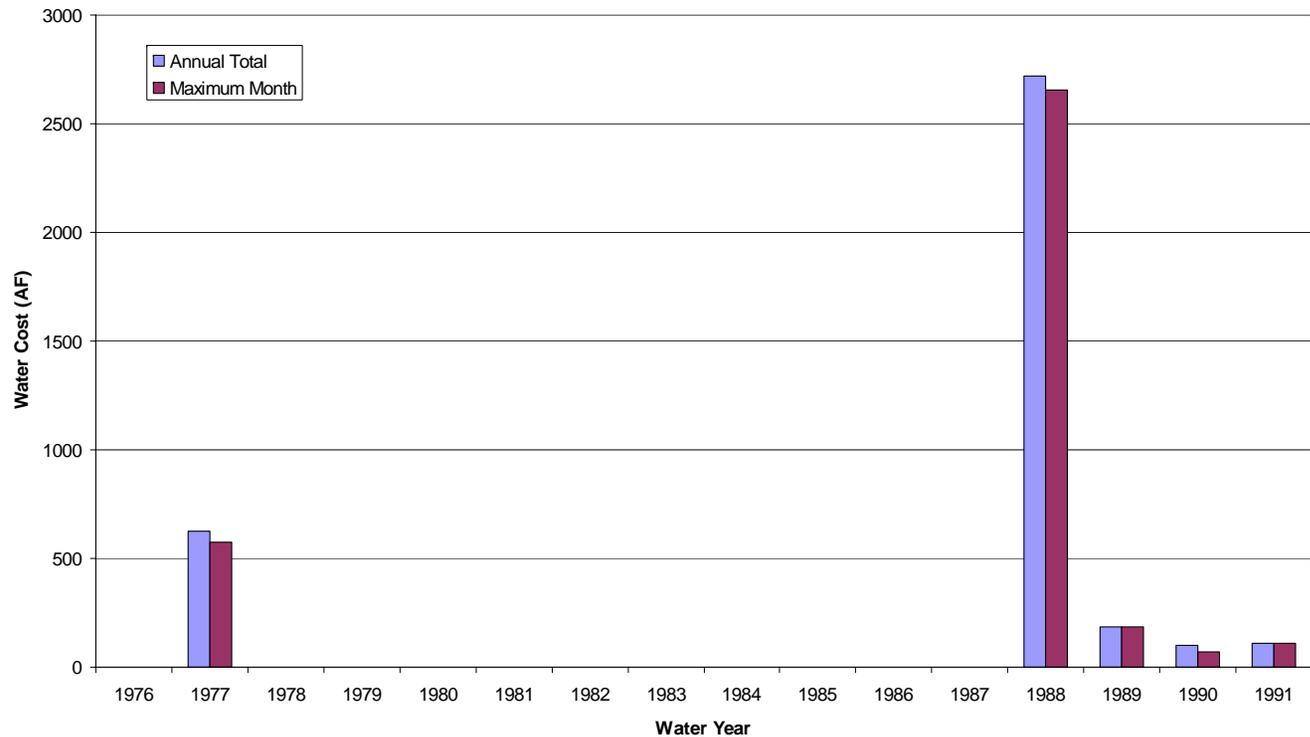
# Water Cost for 100 cfs Flow at Brandt Bridge (based on daily deficit)

Water Cost to meet 100 cfs at Brandt Bridge

- 100 cfs minimum: average of 234 AF / yr (daily)
- 100 cfs minimum: average of 1734 AF / yr (monthly)
- 600 cfs minimum: average of 23,000 AF / yr (daily)

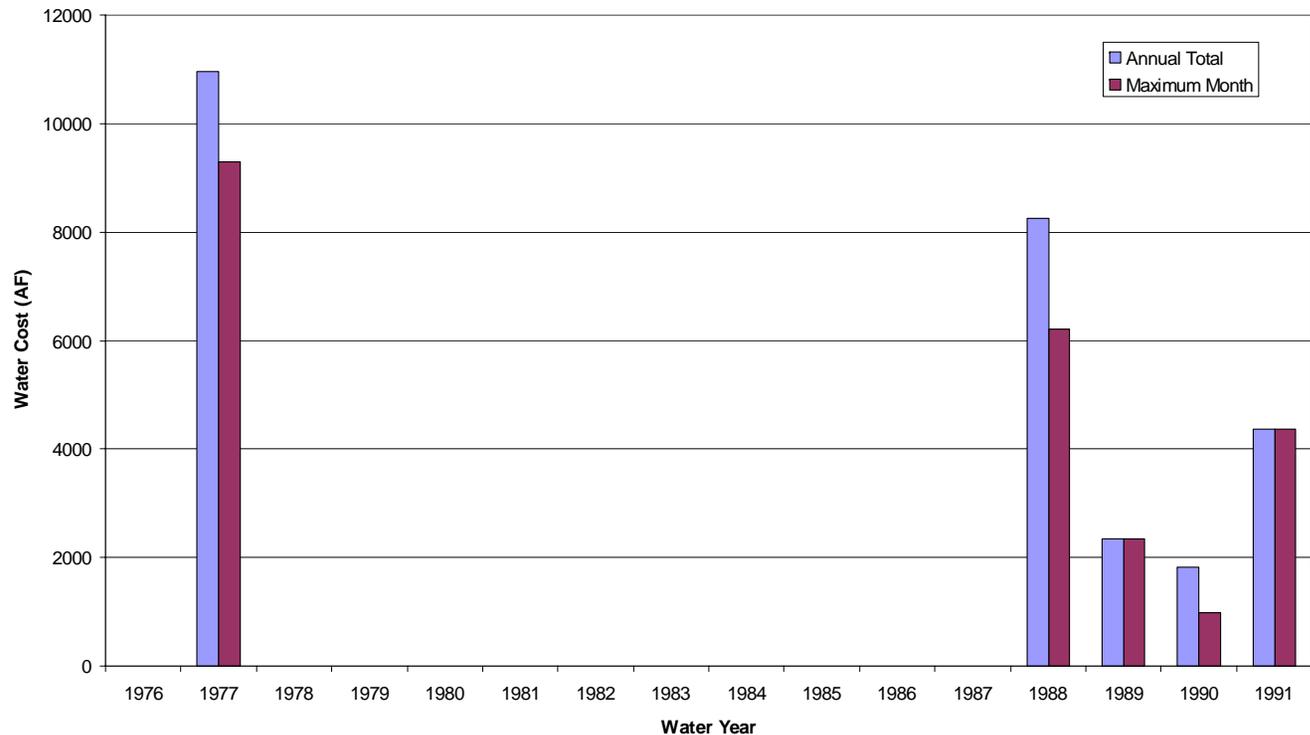
# Water Cost for 100 cfs Flow at Brandt Bridge (based on monthly operation)

Water Cost to meet 100 cfs at Brandt Bridge

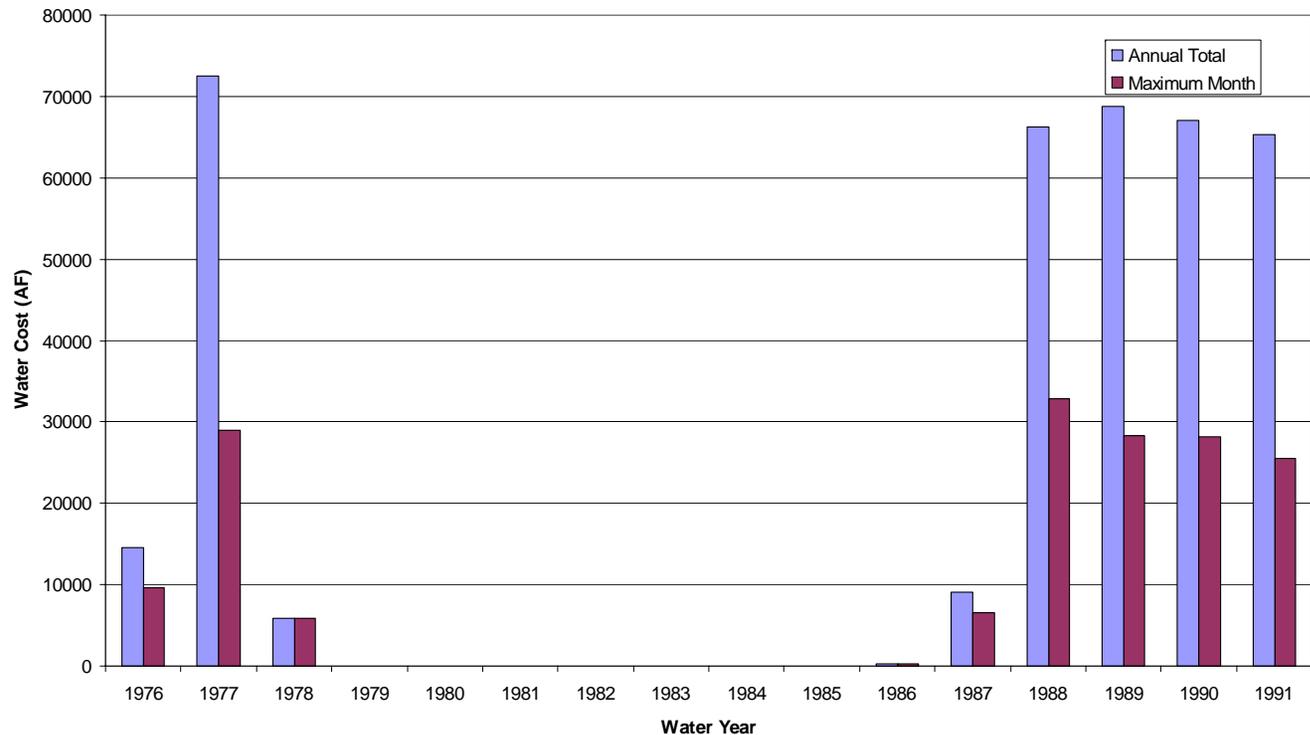
# Water Cost for 600 cfs Flow at Brandt Bridge (based on daily deficit)

Water Cost to meet 600 cfs at Brandt Bridge

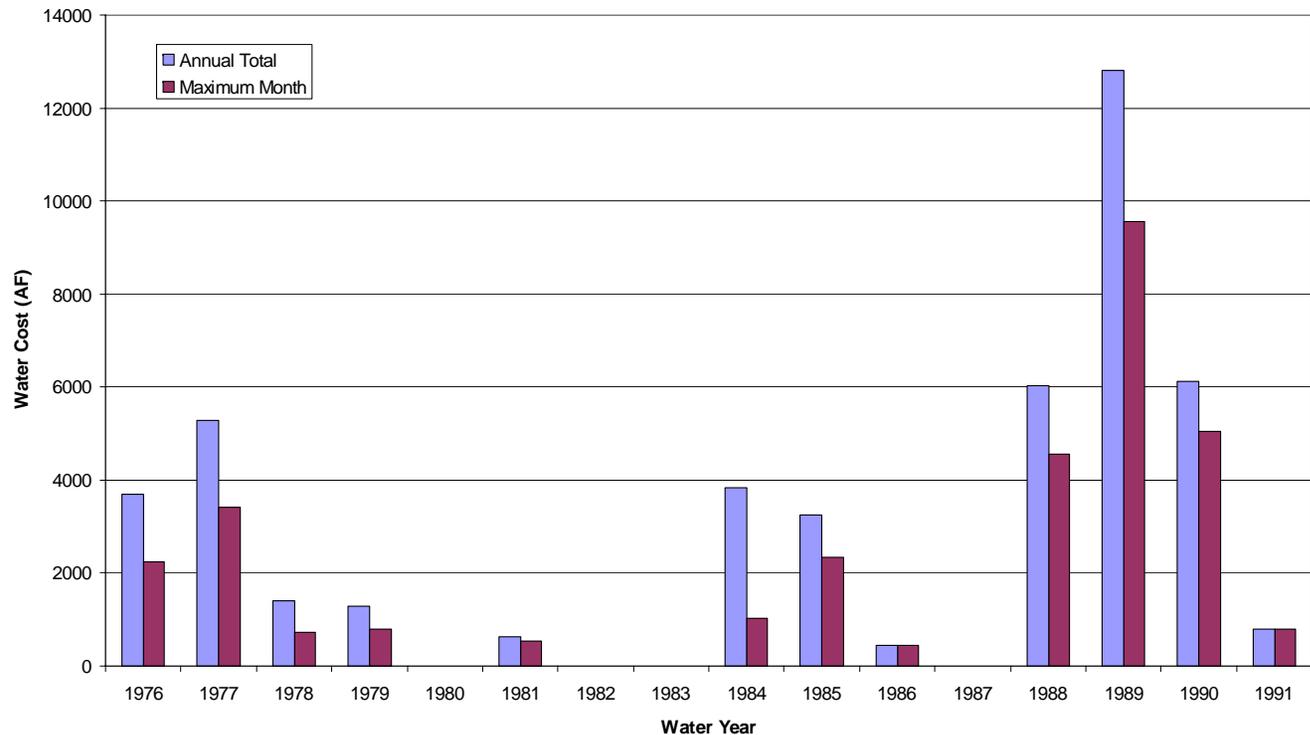
# Water Cost at Vernalis to meet Peak Daily DICU Demand and 100 cfs at Brandt Bridge

Water Cost to meet 100 cfs at Brandt Bridge and Peak DICU
