APPENDIX G

Appendix G, Table 1
 Site Descriptions for Water Temperature Monitoring Locations in the San Joaquin River and Delta as Part of the 2011 Vernalis Adaptive Management Program (VAMP)

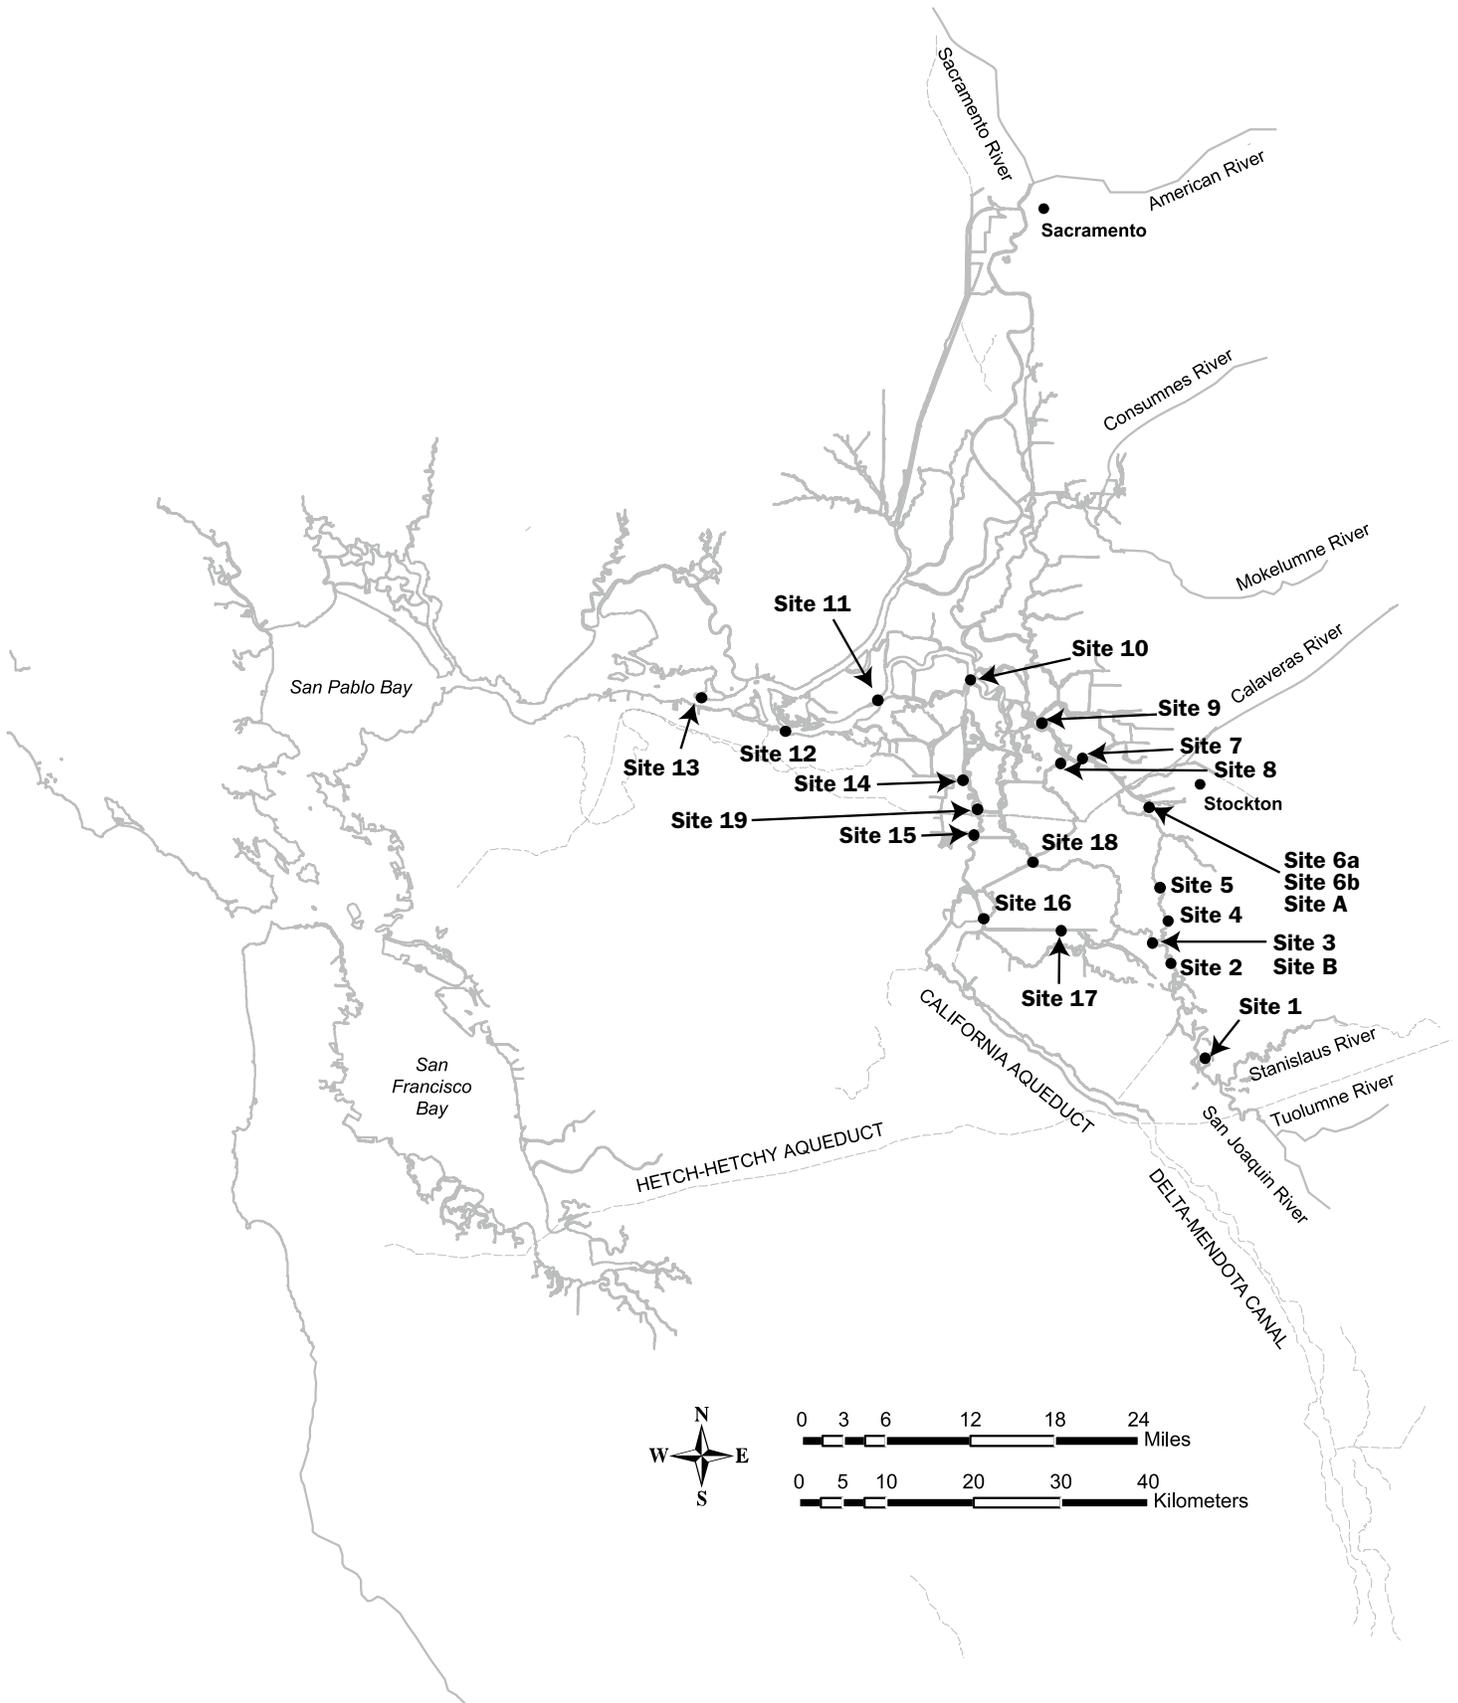
Appendix G, Figure 1

Overview of Water Temperature Monitoring Locations in the Lower San Joaquin River and Delta as Part of the 2011 Vernalis Adaptive Management Program (VAMP)

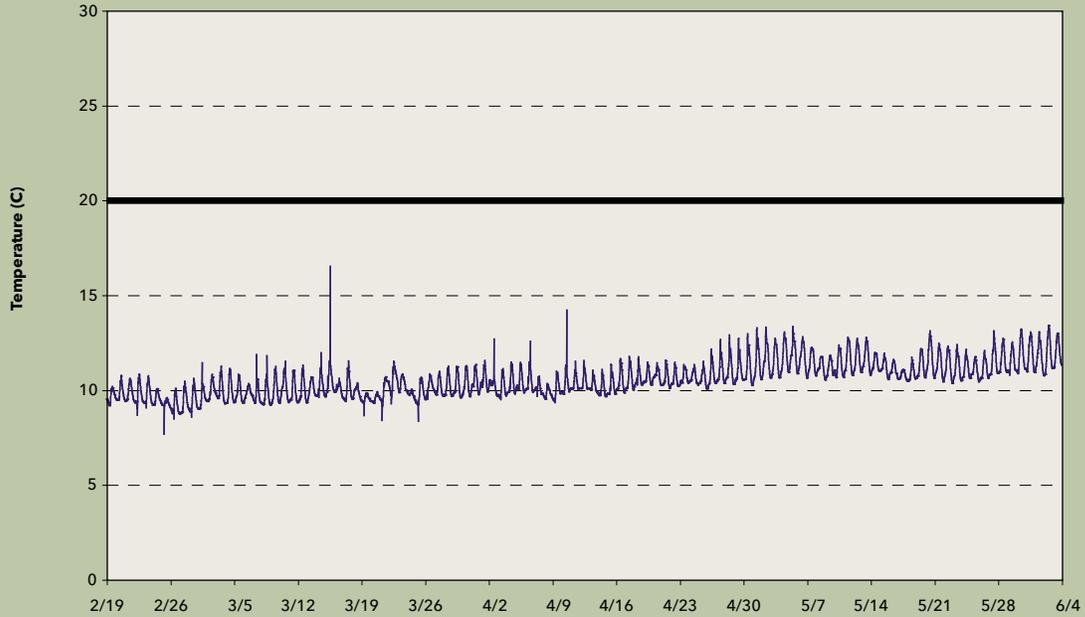
Appendix G, Figure 2
 Daily Water Temperature Fluctuations (°C) at the CDFG Merced River Fish Hatchery with the Fish Designated for Acoustic Tagging During the 2011 Vernalis Adaptive Management Program (VAMP)

*Logger A was placed with acoustic tagged fish in the hatchery building

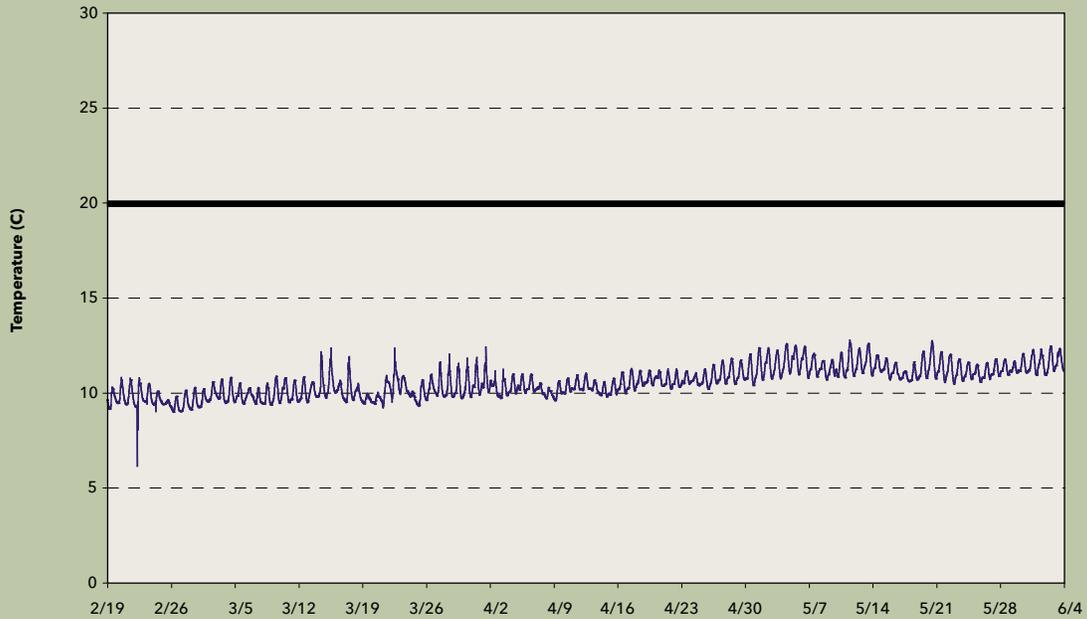
Appendix G, Figure 3
 Daily Water Temperature Fluctuations (°C) at the CDFG Merced River Fish Hatchery with the Control Group of Fish During the 2011 Vernalis Adaptive Management Program (VAMP)

**Logger B was placed with control group fish in the outside hatchery nursery tanks

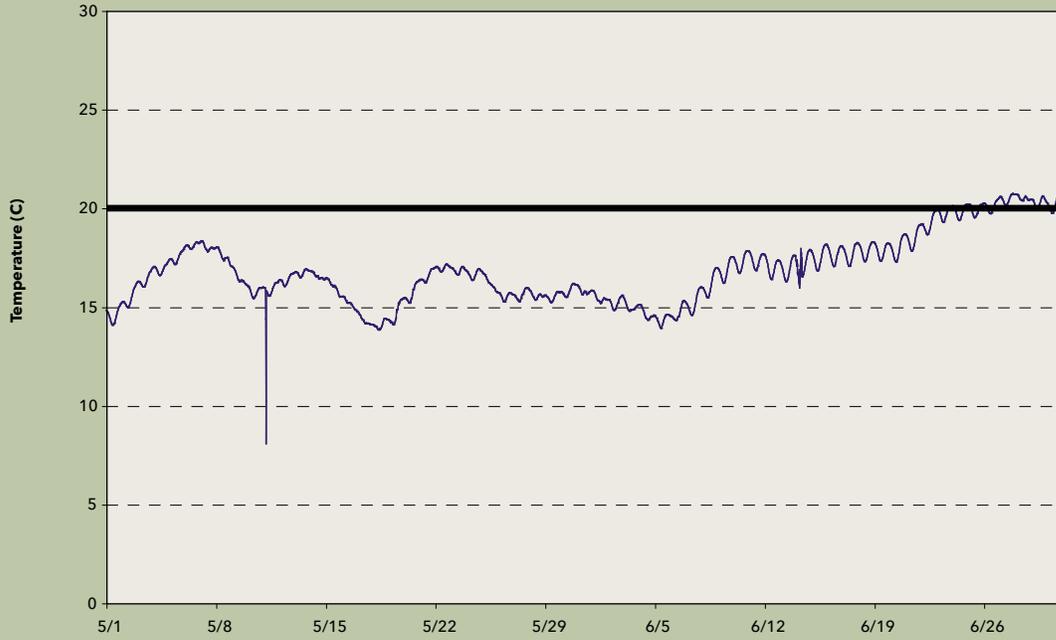
Appendix G, Figure 4
 Daily Water Temperature Fluctuations (°C) in the San Joaquin River at Durham Ferry
 During the 2011 Vernalis Adaptive Management Program (VAMP)

(Recorder may have been dewatered briefly during a one-hour period on 5/11/2012; also logger was dewatered at the time of retrieval due to lower flow)

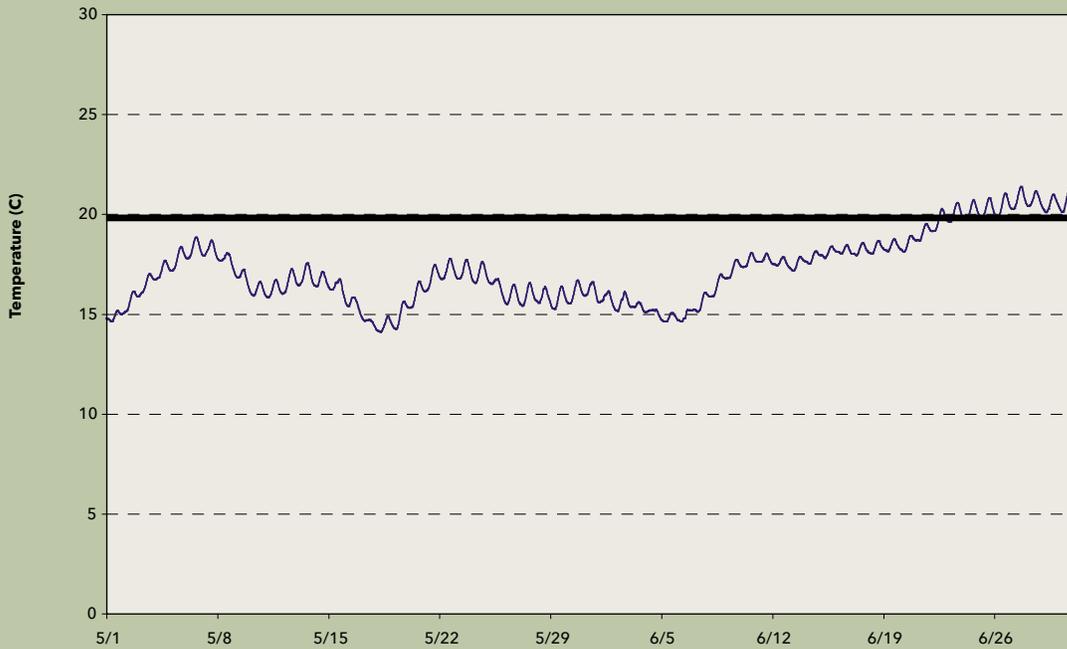
Appendix G, Figure 5
 Daily Water Temperature Fluctuations (°C) in the San Joaquin River at Mossdale Bridge
 During the 2011 Vernalis Adaptive Management Program (VAMP)

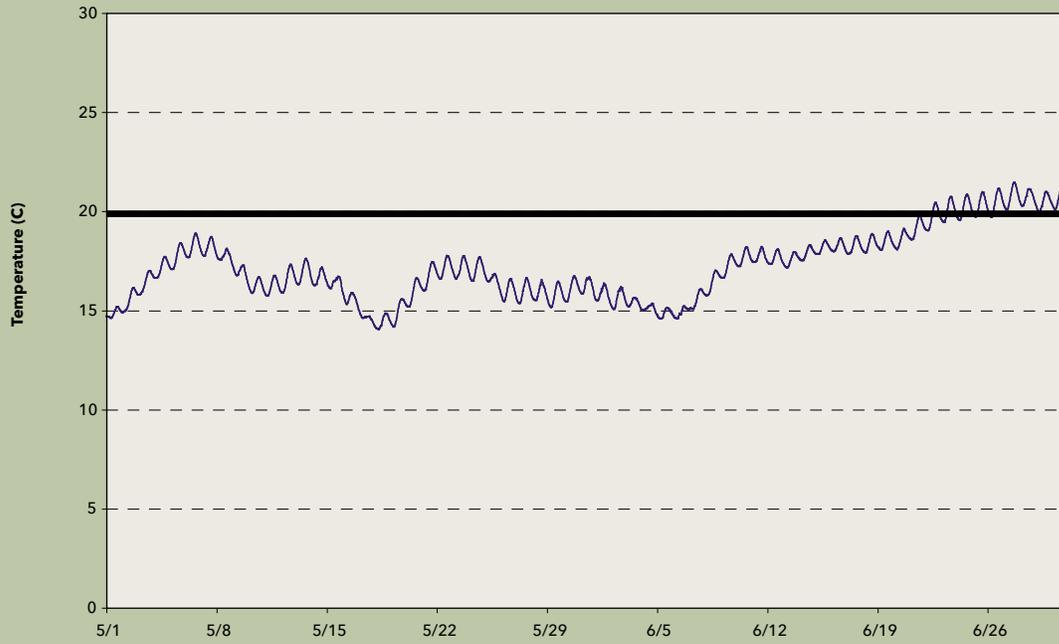
Appendix G, Figure 6
 Daily Water Temperature Fluctuations (°C) in Old River at the Head of Old River Barrier
 During the 2011 Vernalis Adaptive Management Program (VAMP)

(Recorder was dewatered at the time of retrieval)

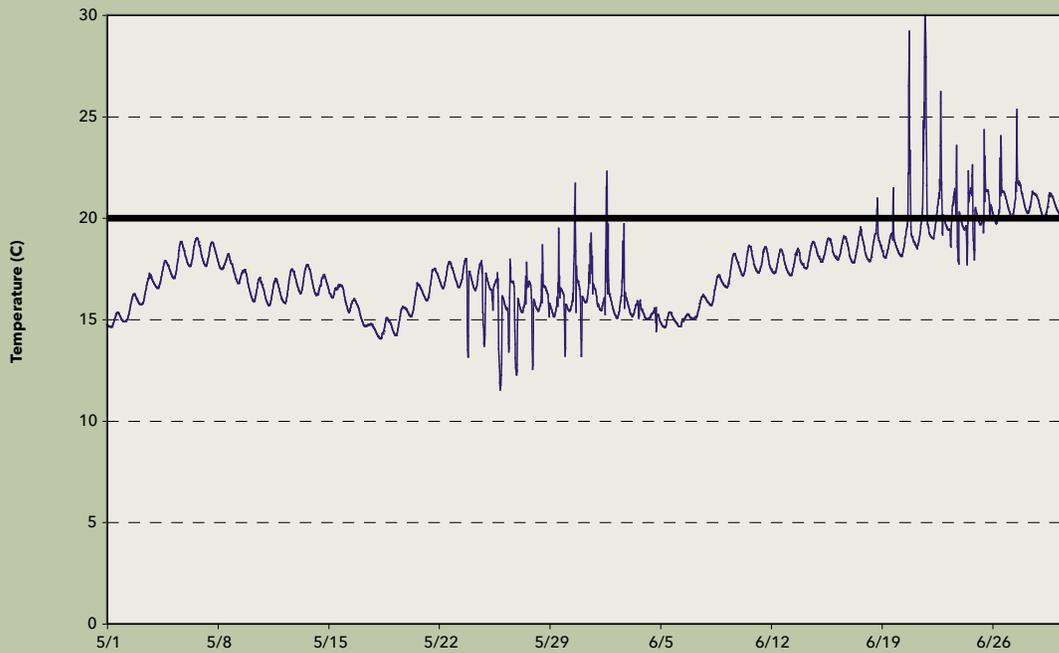
Appendix G, Figure 7
 Daily Water Temperature Fluctuations (°C) in the San Joaquin River at Dos Reis
 County Park During the 2011 Vernalis Adaptive Management Program (VAMP)

(Recorder was dewatered at the time of retrieval and data shows it may have been dewatered on numerous occasions)

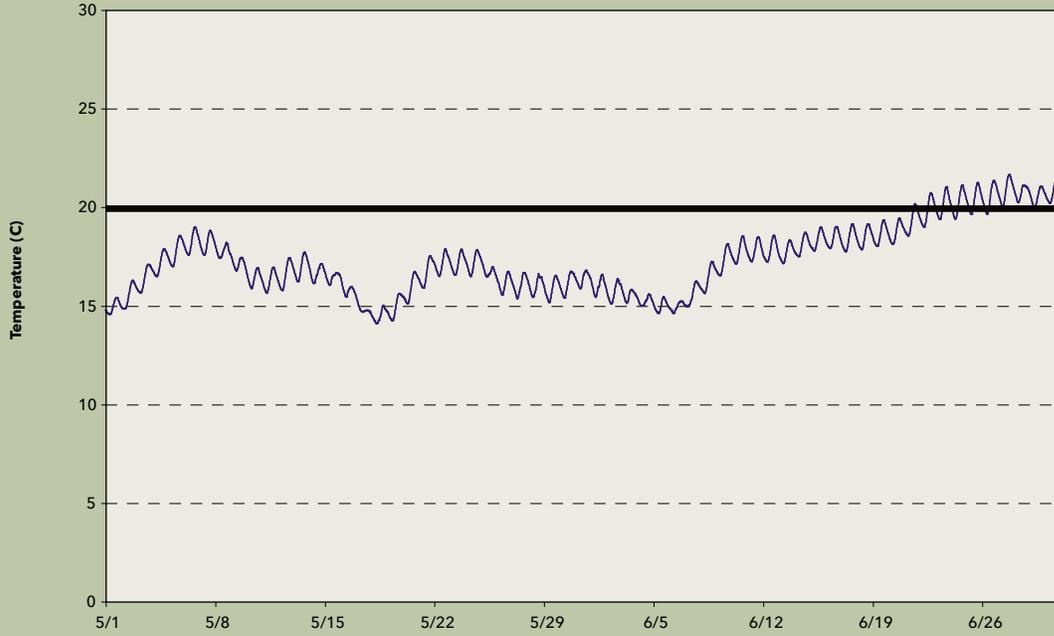
Appendix G, Figure 8

Daily Water Temperature Fluctuations (°C) in the San Joaquin River at the DWR Flow Monitoring Station Near Lathrop During the 2011 Vernalis Adaptive Management Program (VAMP)

(Recorder was found at the water surface on the day of retrieval)

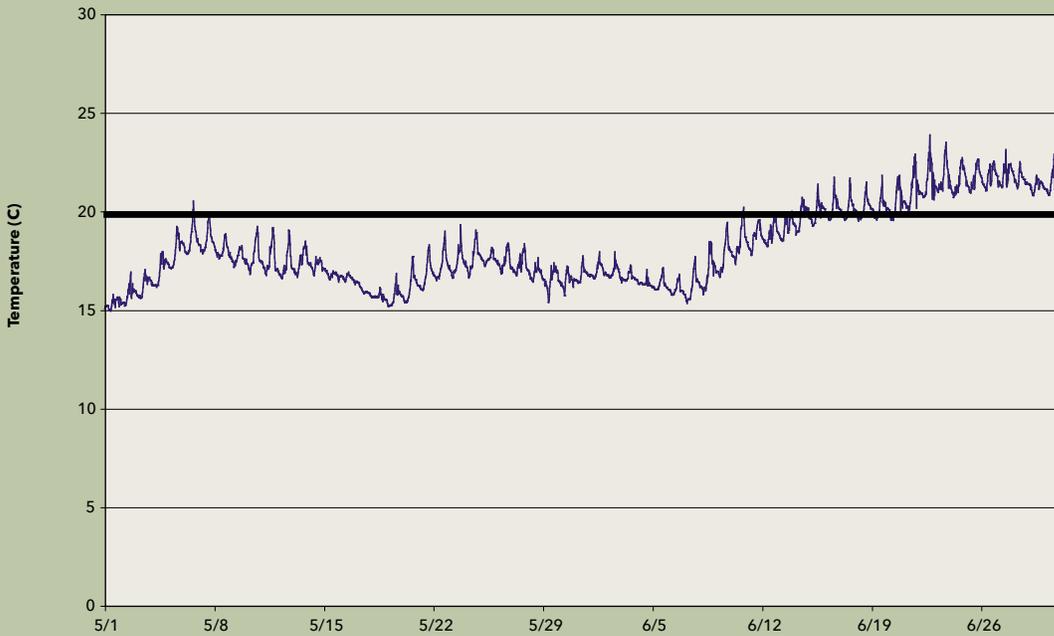
Appendix G, Figure 9

Daily Water Temperature Fluctuations (°C) in the San Joaquin River Upstream of Channel Marker No 33 During the 2011 Vernalis Adaptive Management Program (VAMP)

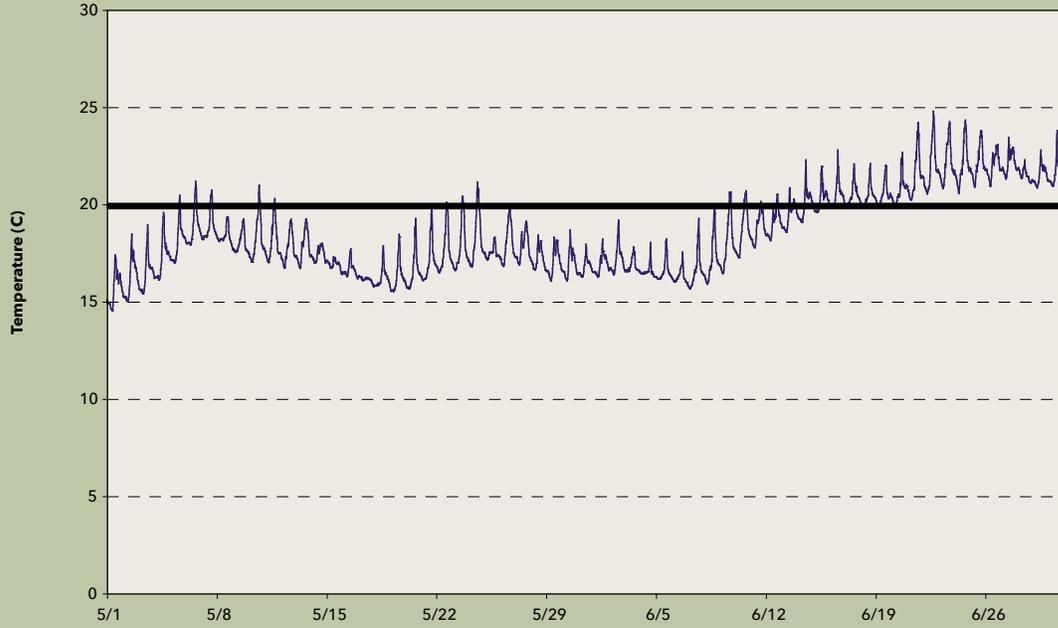
Appendix G, Figure 10
 Daily Water Temperature Fluctuations (°C) in the San Joaquin River at Turner Cut (Channel Marker 21-22) During the 2011 Vernalis Adaptive Management Program (VAMP)

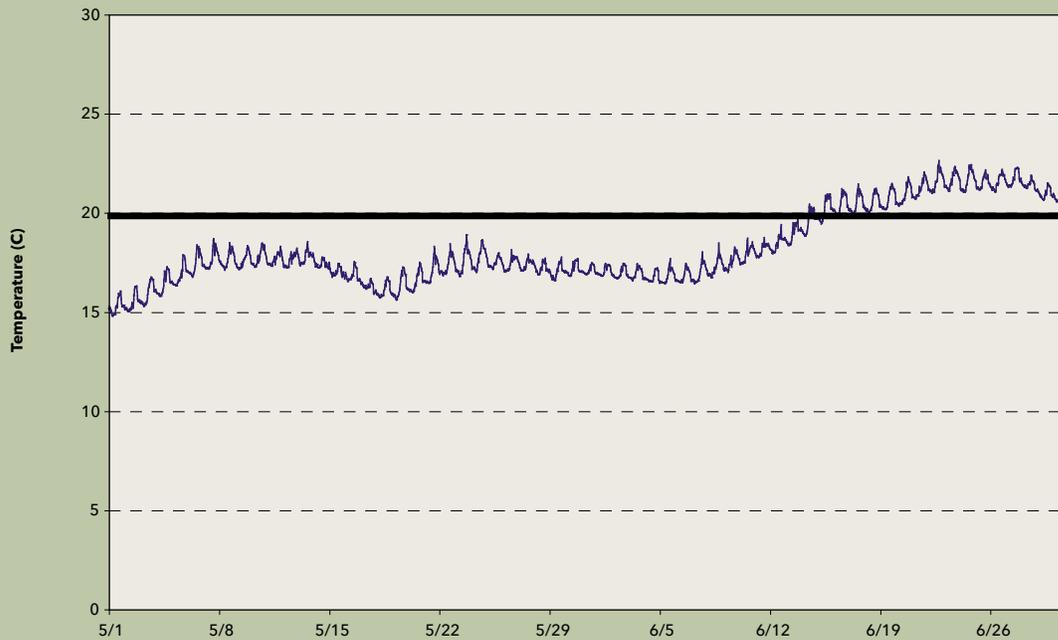
Appendix G, Figure 11
 Daily Water Temperature Fluctuations (°C) in the San Joaquin River at the All Pro Abandoned Boat During the 2011 Vernalis Adaptive Management Program (VAMP)

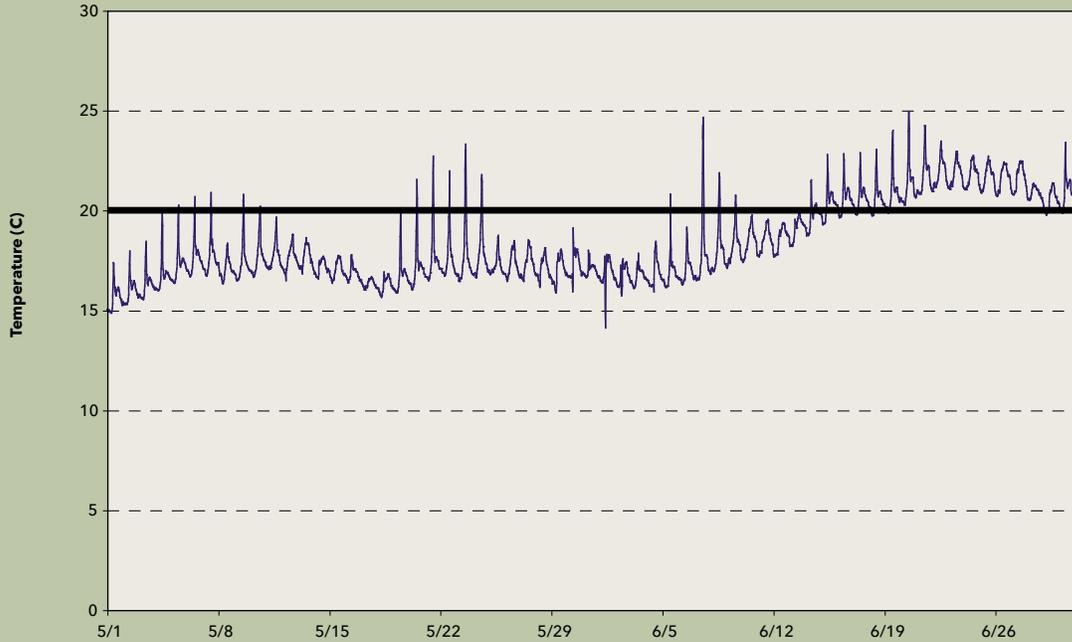
Appendix G, Figure 12
 Daily Water Temperature Fluctuations (°C) in the San Joaquin River Near the Antioch Marina During the 2011 Vernalis Adaptive Management Program (VAMP)

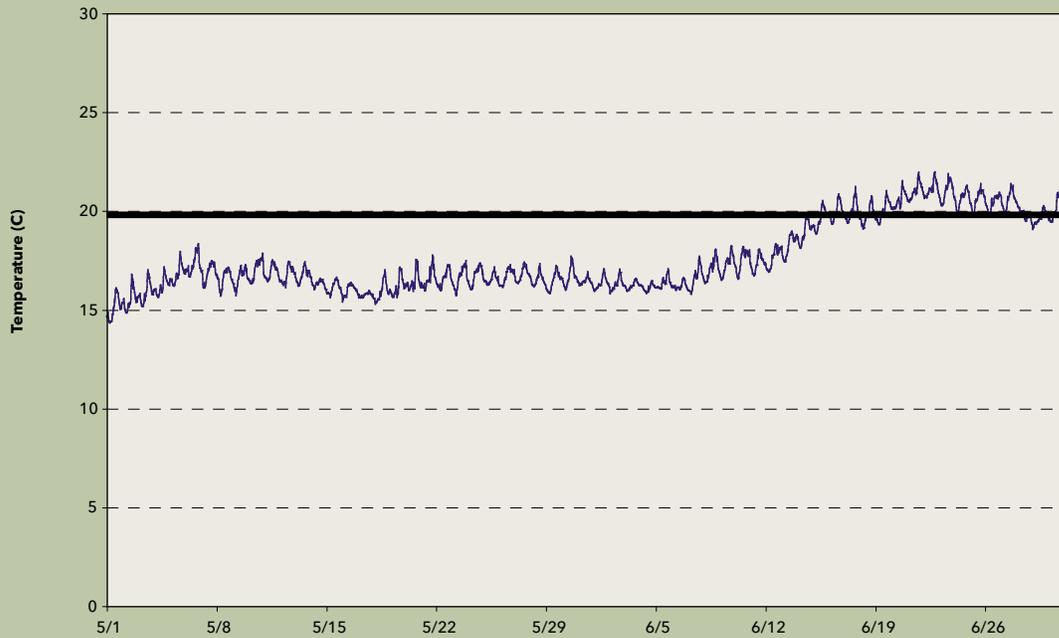
Appendix G, Figure 13
 Daily Water Temperature Fluctuations (°C) in the South Delta Near Chipps Island During the 2011 Vernalis Adaptive Management Program (VAMP)

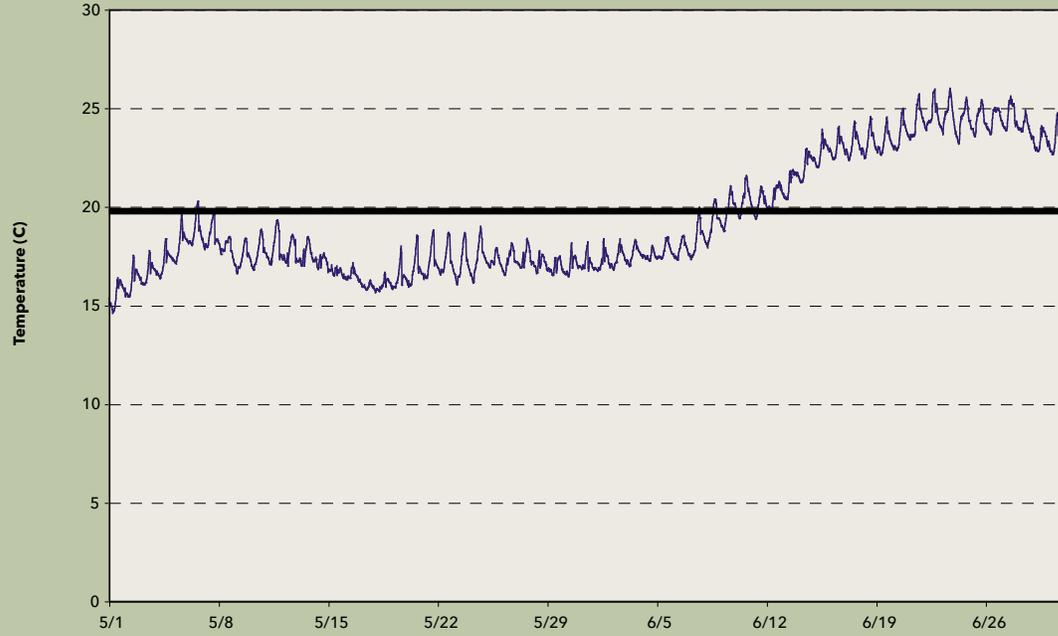
Appendix G, Figure 14
 Daily Water Temperature Fluctuations (°C) in the South Delta Near the Old River/Indian Slough Confluence
 During the 2011 Vernalis Adaptive Management Program (VAMP)

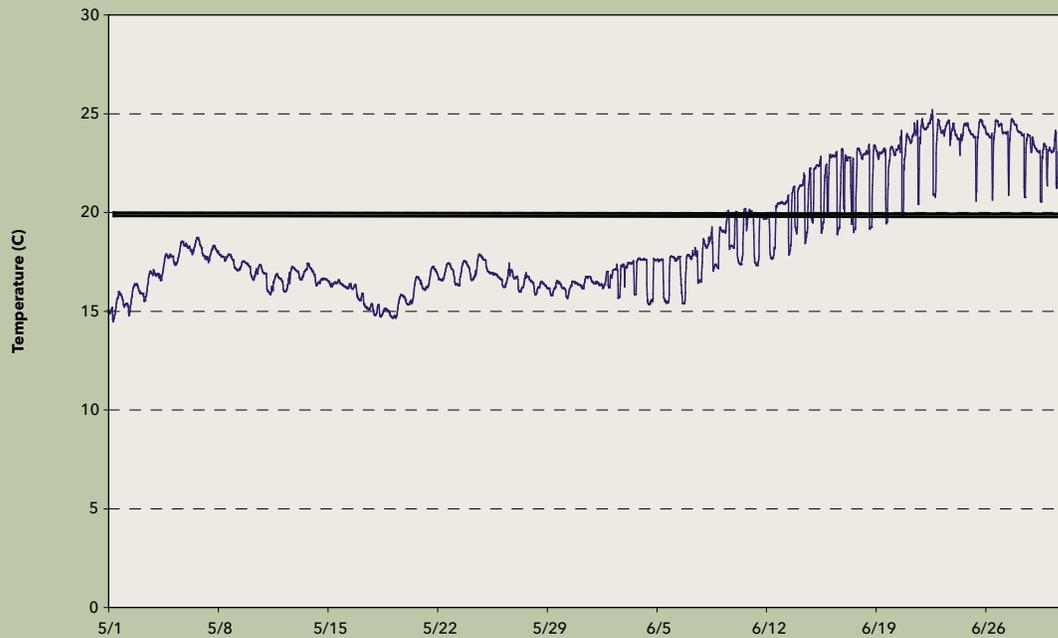
Appendix G, Figure 15
 Daily Water Temperature Fluctuations (°C) in the South Delta Near the CCF Radial Gates
 During the 2011 Vernalis Adaptive Management Program (VAMP)

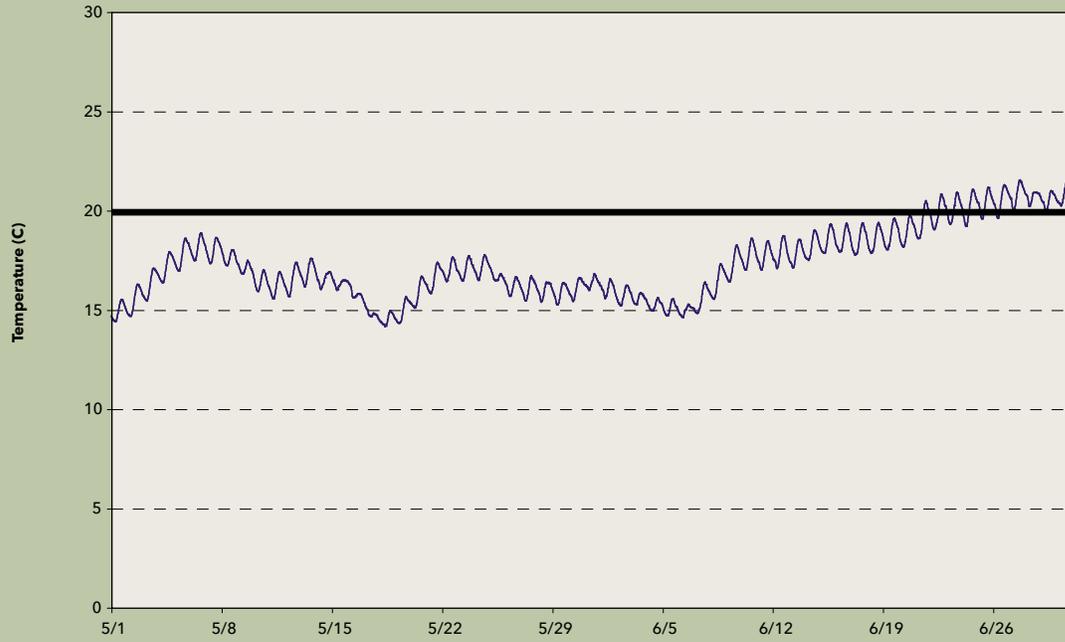
Appendix G, Figure 16
 Daily Water Temperature Fluctuations (°C) in the South Delta in the Grant Line Canal at Tracy Blvd Bridge During the 2011 Vernalis Adaptive Management Program (VAMP)

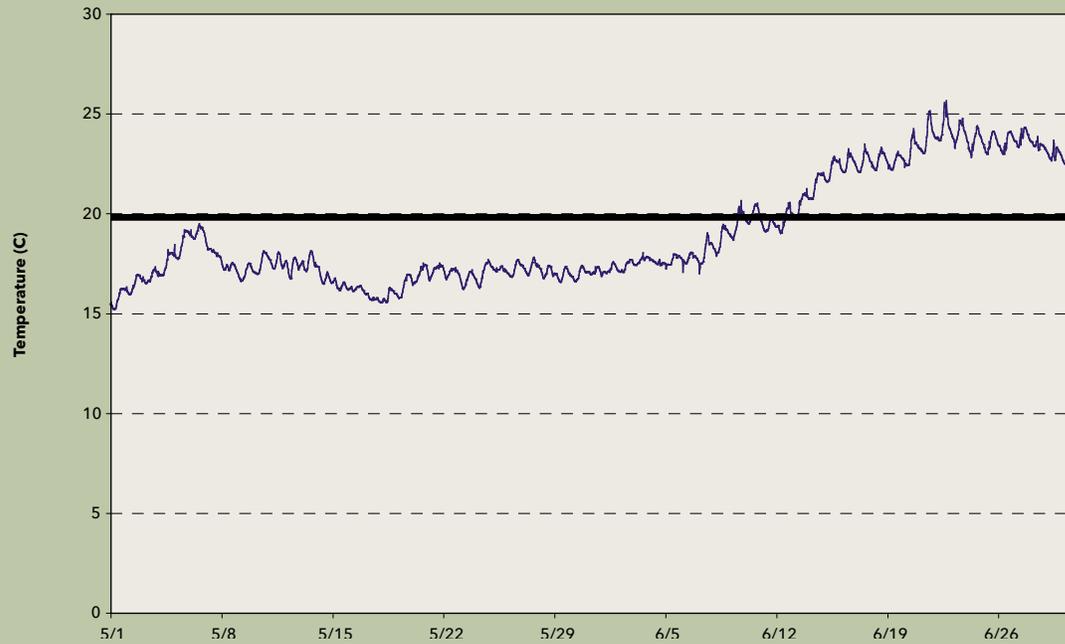
Appendix G, Figure 17
 Daily Water Temperature Fluctuations (°C) in the South Delta Near Union Point During the 2011 Vernalis Adaptive Management Program (VAMP)

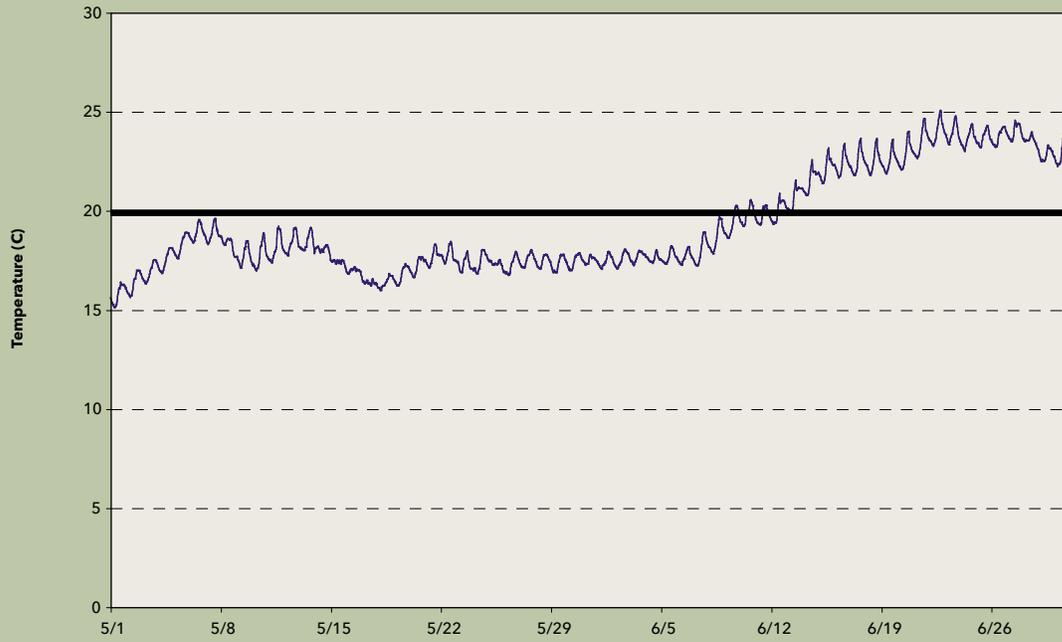
Appendix G, Figure 18
Daily Water Temperature Fluctuations (°C) in Werner Cut at the Channel Above Woodward Isle During the 2011 Vernalis Adaptive Management Program (VAMP)
