## Element 2 - Swainson's Hawk Survey and Monitoring Report Temporary Barriers Project 2011 Construction Season

The following is the report on Swainson's Hawk surveys and monitoring for the Temporary Barriers Project construction activities in the 2011 nesting season, described below. Swainson's Hawk surveys were initiated at all Temporary Barrier construction and storage sites April 8, 2011. Surveys, construction monitoring, and post-construction monitoring continued through July 26, 2011.

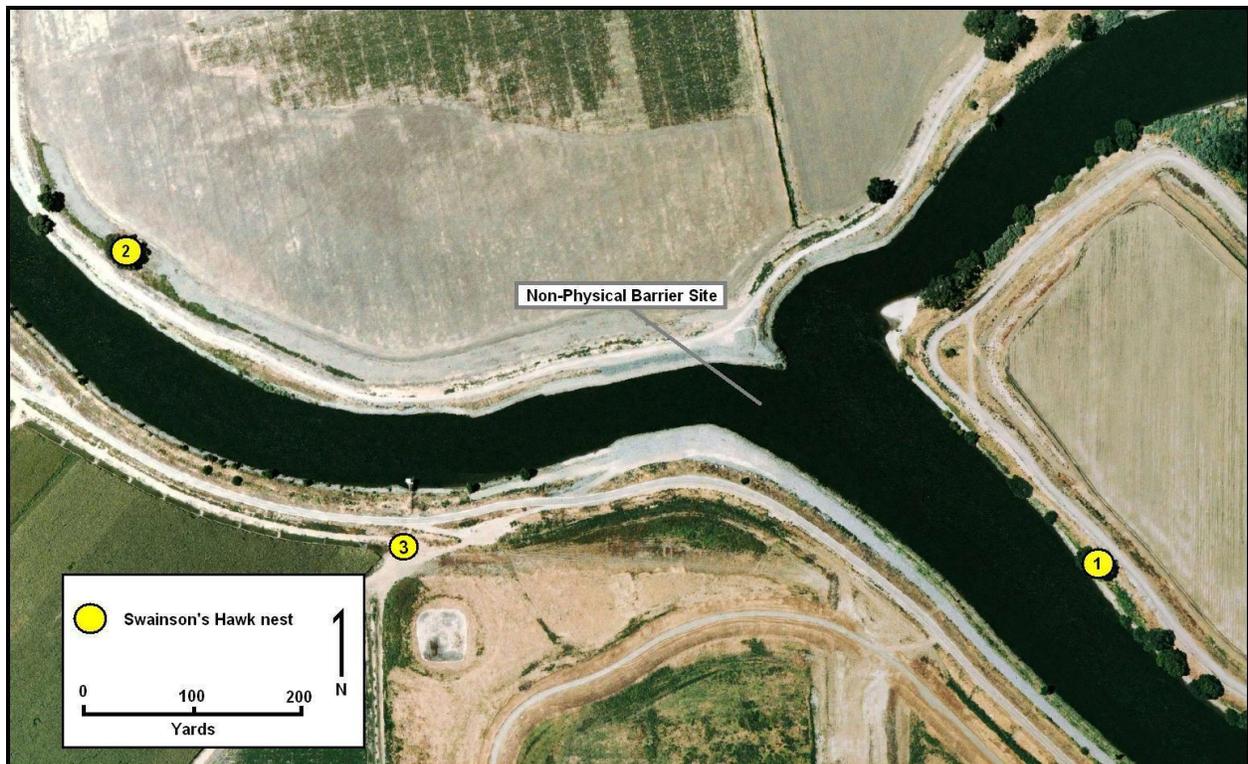
Pre-nest surveys indicated that Swainson's Hawks were likely to nest at typical locations (figure 1). Nests were constructed upstream of the barrier site in a cottonwood/willow tree group (1), downstream of the barrier on the north levee in a large oak (2), and downstream on the south side of the levee in an old walnut (3). One adult was observed on numerous occasions standing in the nest, but did not appear to be mated, and eventually abandoned the site. No project-related effects were noted.

Figure 1. Swainson's Hawk nests at the Head of Old River barrier site in 2011.

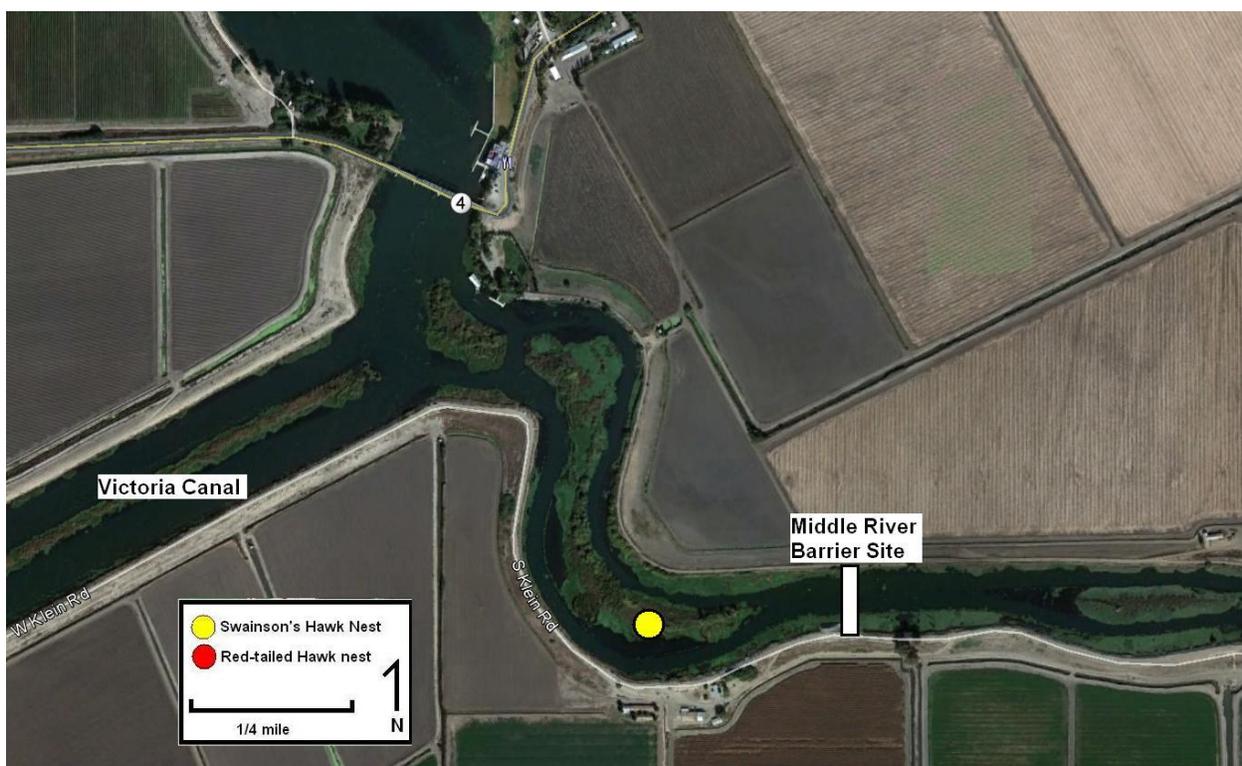
The MR barrier site was surveyed/monitored beginning on April 8 through June 15. A pair of Swainson's Hawks constructed a nest on the island west of the barrier site (figure 2), but on May 27, they were not on the nest and there were no chicks in the nest. The adults were mating, indicating that they may have had an initial nest failure. The pair did not successfully nest in 2011 at that site. No project-related effects were noted.

Figure 2. Raptor nests at Middle River barrier site in 2011.

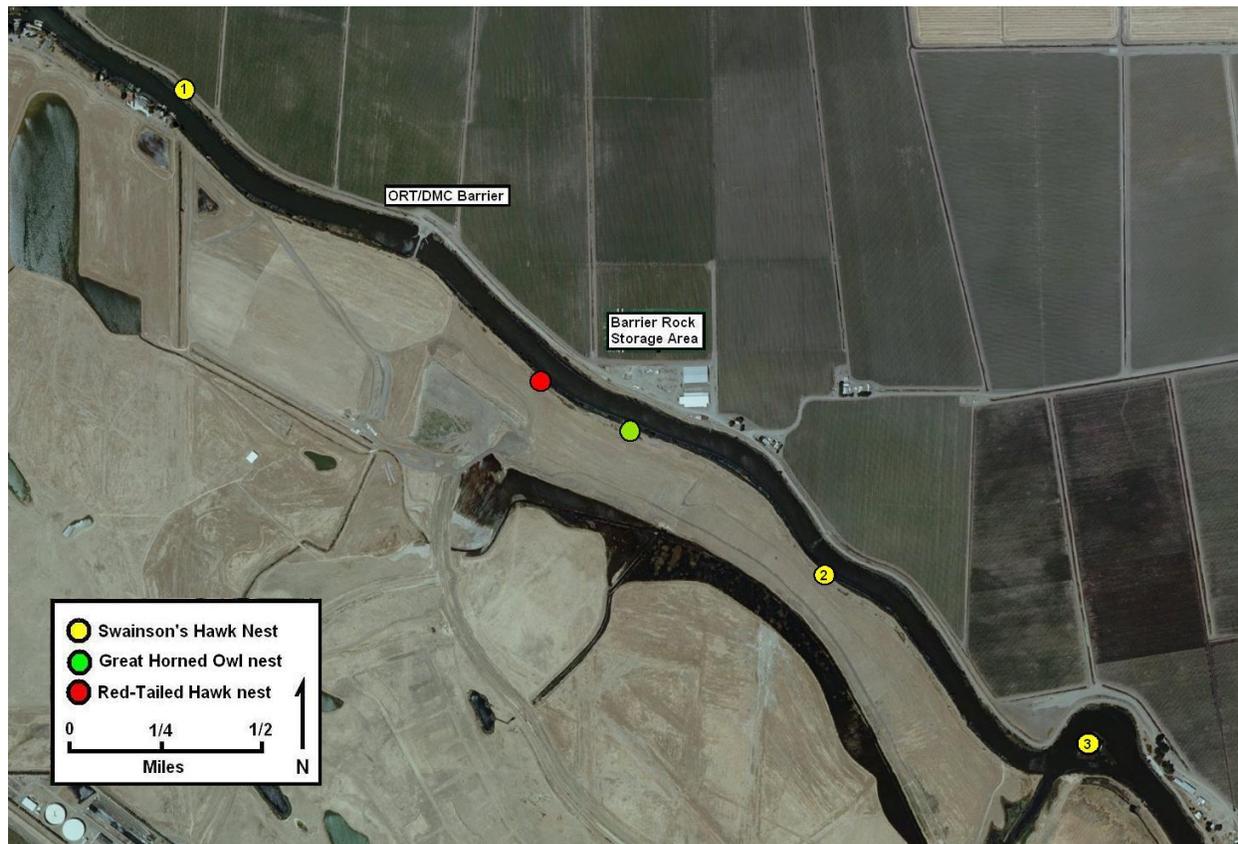
Three Swainson's Hawk nests, one Red-tailed Hawk nest, and one Great Horned Owl nest were found from the instream island southeast of the barrier, to the large pine tree to the northeast (figure 3). On May 13, all nests were active; the Swainson's Hawks were incubating eggs, and the Red-tailed Hawk and Great Horned Owl had chicks. On May 27, prior to the initiation of construction of the ORT barrier and following a cold storm with high wind and hail, Swainson's

Hawk nests 1 and 2 had failed, as had the Red-tailed Hawk nest. The Great Horned Owl nest may have failed, but due to the size and mobility of the chicks, they simply may not have been

Figure 3. Raptor nests at Old River, Tracy barrier site in 2011.

visible within the branches of their nest tree. Only the Swainson's Hawks nesting on the island (nest 3) were known to successfully fledge young. All nest failures at the site were assumed to be weather related. No project effects were noted.

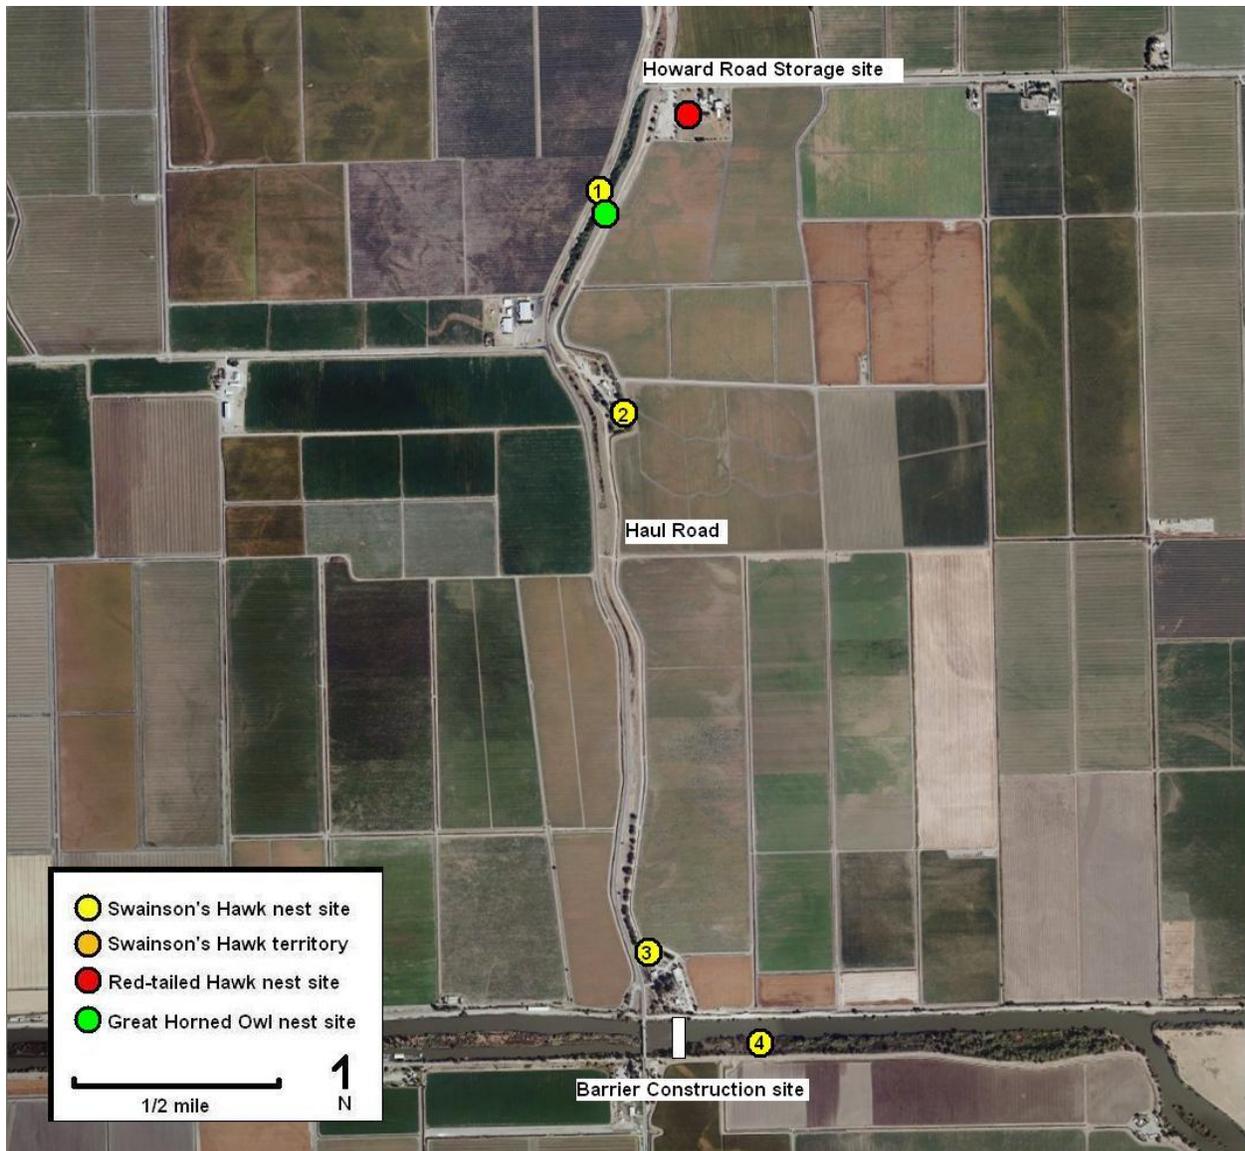
Raptor surveys of the GLC rock storage site, haul road and barrier site were initiated on April 8 and continued through July 26 at which time all raptor chicks were fledged. Six raptor nests were identified and monitored throughout the nesting and construction season (figure 4). A Red-tailed Hawk nested in a pine tree east of and adjacent to the Howard Road rock storage site and fledged 2 young. A Great Horned Owl nested in a willow between Howard Road and Clifton Court Road and fledged 4 young.

By July 14, the Swainson's Hawk pairs at nest sites 1 and 3 fledged 2 young and 1 young, respectively. The Swainson's Hawk pairs at nest sites 2 and 4 failed prior to the initiation of

Figure 4. Raptor nests near the Grant Line Canal construction facilities in 2011.

construction at the site, and with proximal timing to other area nest failures.

The male adult from nest 3 was severely injured near the haul road while construction activities were ongoing, but it is unknown how the injury occurred. The bird was taken to UC Davis Veterinary Center, and later sent to the Raptor Center, where it eventually recovered and was released. The day after the male was injured, the female adult Swainson's Hawk at nest 3 found a new mate and provider for her 3 week old chick. As stated above, the chick eventually fledged.
