State of California
The Resources Agency
Department of Water Resources
Division of Environmental Services, Fish Facilities Section

A Pilot Study on the Bio-fouling Resistance of
304 and 316 Stainless Steels and Copper Nickel Metal.

July 28, 2005

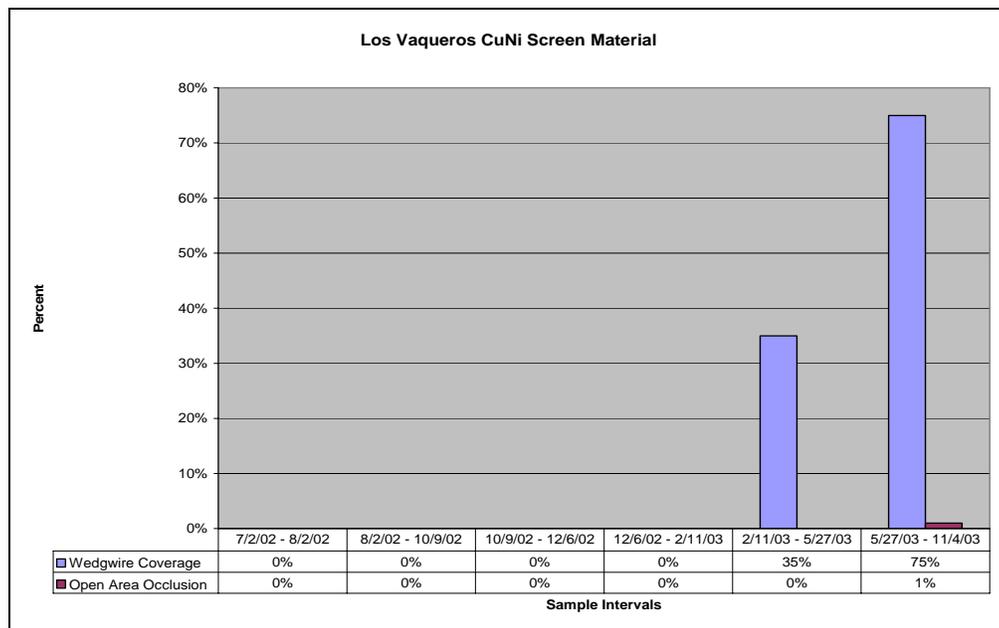
Chart 1. Los Vaqueros site - Percent wedgewire surface face coverage and coupon open area occlusion for CuNi metal.

Very little material was visible on the CuNi screen coupons throughout the study (Chart 1). Of the six sample intervals, only two produced biofouling on the CuNi screen coupons. The fouling consisted of a very thin layer of black algae (see taxonomic table for identification). Thirty five percent coverage of the wedgewire face and 0% open area occlusion occurred during the sample interval of February 11, 2003 and May 27, 2003. The sample interval of May 27, 2003 through November 4, 2003 produced 75% wedgewire face coverage and 1% open area occlusion. The biofouling was easily rubbed off and did not block or obstruct the open area of the screen. Minimal effort was needed to clean the screens thoroughly. See photos in Appendix.

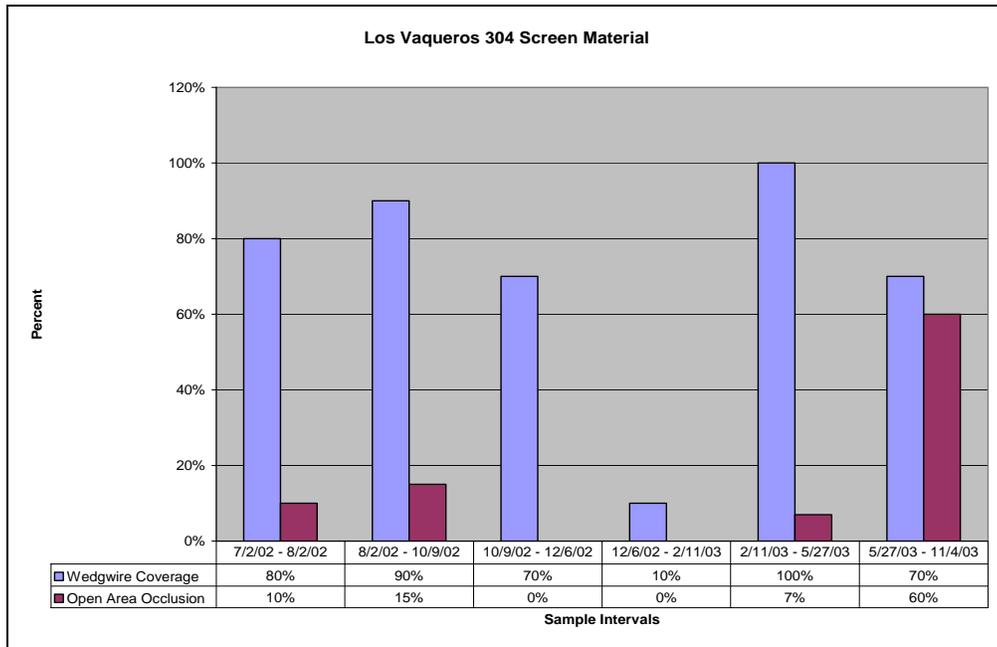
Chart 2. Los Vaqueros site – Percent wedgwire surface face coverage and coupon open area occlusion for 304 stainless steel.

The 304 and 316 coupons did not perform as well as the CuNi coupons. Biofouling was observed on the 304 and 316 coupons for all sample intervals (Charts 2 and 3). The highest percent coverage occurred during the sampling interval of February 11, 2003 to May 27, 2003. This sample interval produced 100% coverage of the wedgewire surface face for both 304 and 316 coupons. The

coupons were 5% covered with sponge and 95 percent covered with a thin brown layer of algae. Although the coverage was very high during this interval, the open area occlusion was only 7%. The greatest percentage of open area occlusion occurred during the interval of May 27, 2003 through November 4, 2003. This interval produced 70% wedgewire face coverage and 60% open area occlusion (Figure 10). The high percentage of occlusion can be attributed to the large quantity of fresh water sponge on the coupons. This site consistently produced sponge growth on the coupons and visual inspections throughout the study indicate that the sponge first set hold on the wedgewire support members and then spread throughout the screen if given enough time. In the early stage of sponge establishing itself on the screens, it was found only on the wedgewire supports members. There was no visible difference in the amount of fouling between the 304 and 316 coupons. Light to moderate scrubbing with a plastic spatula and nylon brush was necessary to remove the biofouling from the coupons.

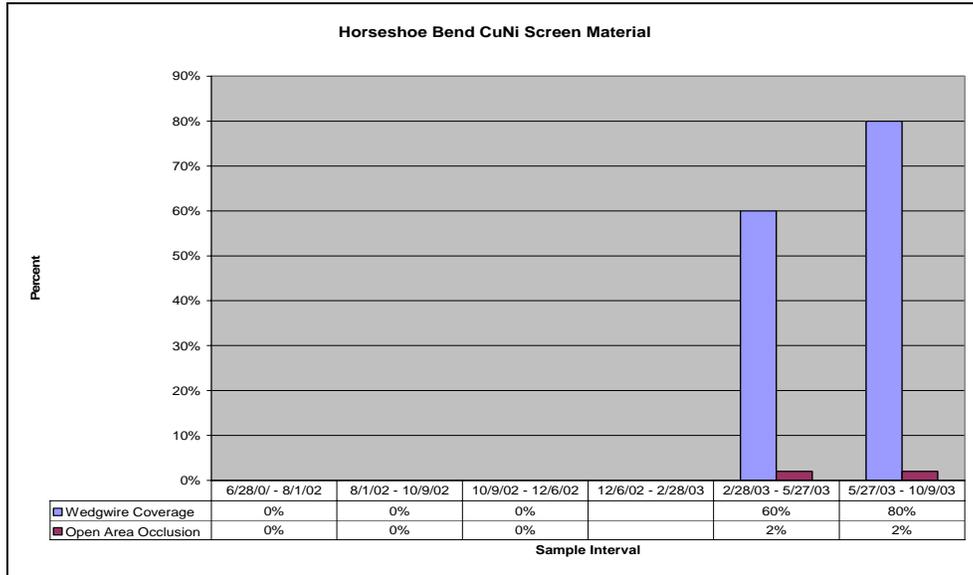
Chart 4. Horseshoe Bend site - Percent wedgwire surface face coverage and coupon open area occlusion for CuNi metal.

Similar to the Los Vaqueros site, only two sample intervals (February 28, 2003 through May 27, 2003 and May 27, 2003 through October 9, 2003) caused biofouling on the CuNi screens (Chart 4). The biofouling consisted of a thin layer of black algae and was very similar to that of the Los Vaqueros site. The taxonomic tables in the appendix show that the CuNi coupons from both sites had some of

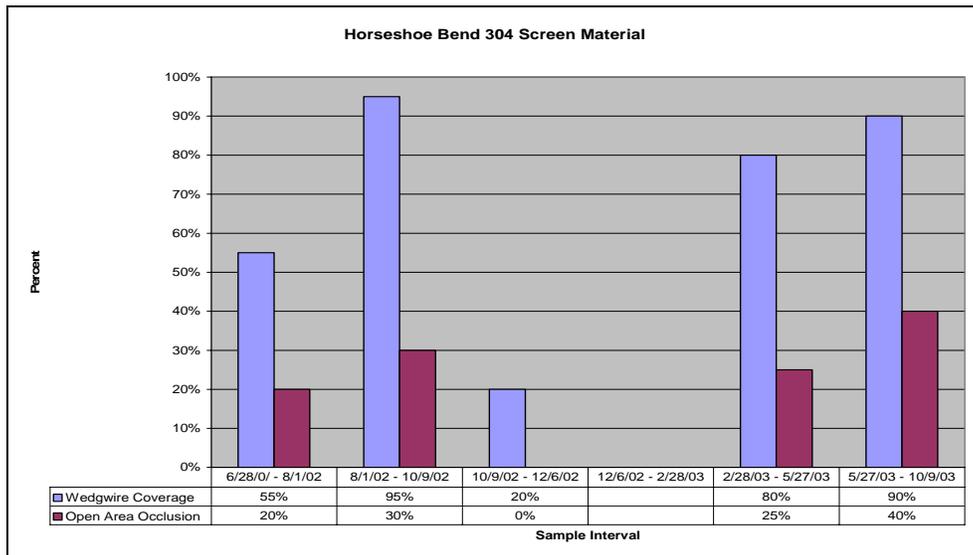
Chart 5. Horseshoe Bend site – Percent wedge wire surface face coverage and coupon open area occlusion for 304 stainless steel.

In contrast to the CuNi, for all intervals biofouling was present on the 304 and 316 coupons. The biofouling at this site was much more filamentous and embedded with silt when compared to the Los Vaqueros site. The highest wedgewire face coverage (95%) for the 304 and 316 coupons occurred during the sampling interval of August 1, 2002 through October 9, 2002 (Figure 11). The coverage consisted of filamentous brown algae embedded with silt. The filamentous alga appears to aid in the build-up of sediment on the coupons. This is evident from photos showing the CuNi wedgewire supports clean with no silt build-up, and the wedgewire supports on the 304 and 316 coupons with fibrous algae and heavy sediment build-up (see photos in appendix). The highest percentage (40%) of open area occlusion occurred during the sample interval of May 27, 2003 through October 9, 2003. The higher percent of open area occlusion is due to the presence of fresh water sponge on the coupons during this interval. It is the only sample interval at this site that produced fresh water sponge. Similar to the Los Vaqueros site, the sponge appears to have originated on the wedgewire supports. The lowest percent (20%) of wedge wire coverage occurred during the sampling interval of October 9, 2002 to December 6, 2002. Filamentous algae were the primary fouling source during this interval. Moderate scrubbing/scraping with a nylon brush and plastic spatula were necessary to remove the filamentous algae from the 304 and 316 coupons.

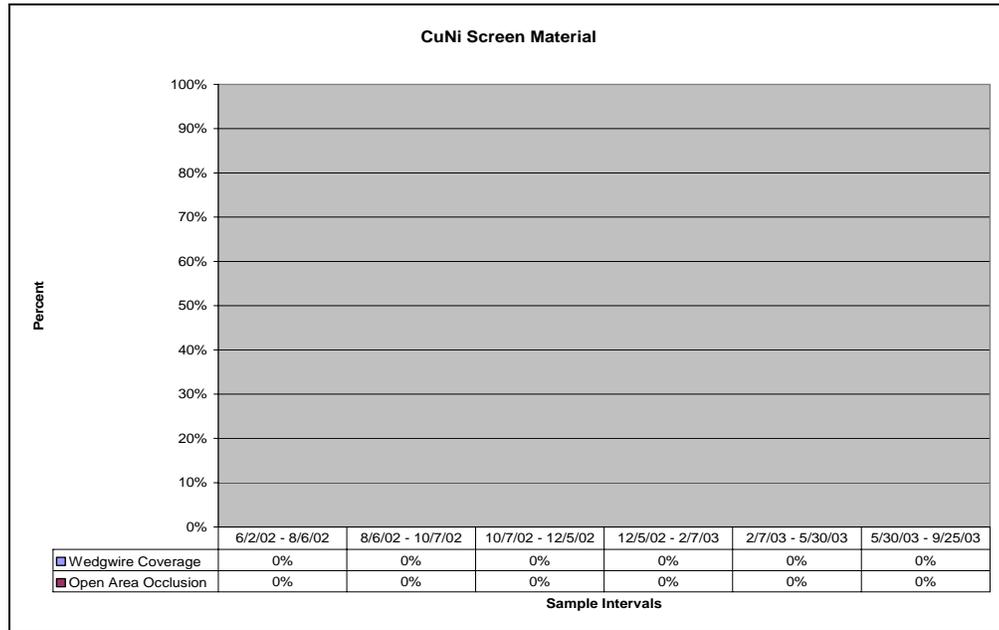
Chart 7. Morrow Island site – Percent of wedgewire surface face coverage and coupon open area occlusion for CuNi metal. Coupons remained free of biofouling for the duration of the study.

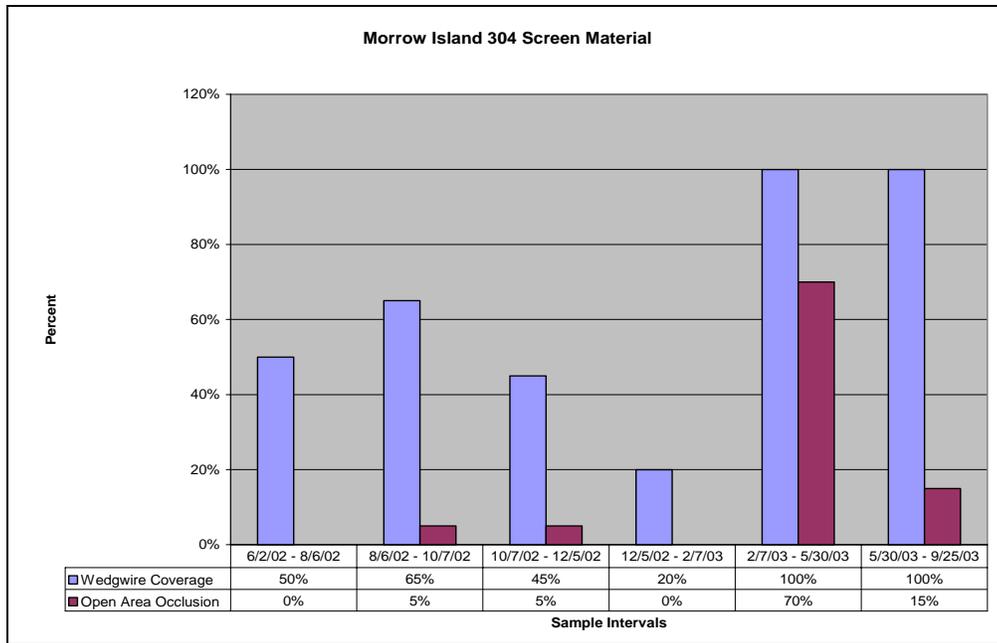
Chart 8. Morrow Island site – Percent of wedgwire surface face coverage and coupon open area occlusion for 304 stainless steel.

For all sample intervals, biofouling was present on the 304 and 316 coupons (Charts 8 and 9). The primary biofouling agents at this site were barnacles and calcareous algae. Most of the barnacles on the screen coupons were attached to the wedgewire supports with only a few attaching to the wedgewire itself. The prevalence of the barnacles on the wedgewire supports could be in part due to larger surface area that is provided by the supports. At this site two intervals, February 7, 2003 through May 30, 2003 and May 30, 2003 through September 25, 2003, produced 100% coverage of the wedgewire surface face. The type of biofouling was very different for both sample intervals. The sample interval of February 7th through May 30th of 2003 produced a web of algae and heavy sediment that covered the 304 and 316 screen coupons (Figure 12). Some barnacles were found attached to the wedgewire under the web of algae. This sample interval also had the highest percentage of open area occlusion at 70%. The very dense web of biofouling blocked the majority of the open area on some of the 304 and 316 coupons. For the sample interval of May 30th through September 25th of 2003, the 304 and 316 coupons were covered with calcareous algae and some barnacles, the same type of biofouling produced during the other sample intervals. Although this interval also had 100% wedgewire face coverage,

the biofouling only produced a 15% occlusion of the 304 and 316 coupon open area. The 304 and 316 coupons required heavy scraping/scrubbing with plastic spatulas and nylon brushes to remove the biofouling.

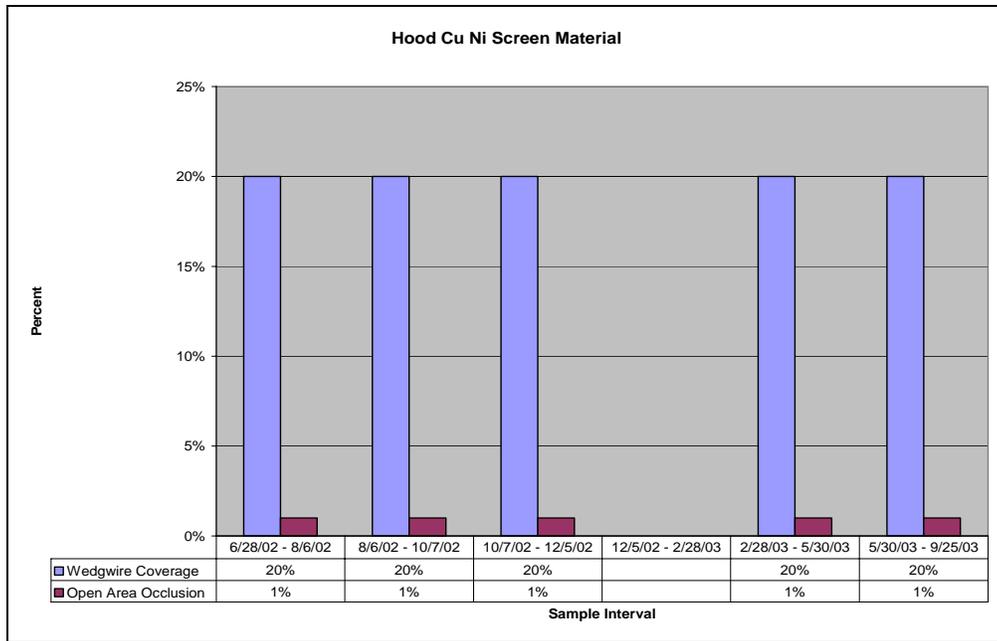
Chart 10. Hood site – Percent of wedgwire surface face coverage and coupon open area occlusion for CuNi metal.

Hood is the only site where visually biofouling material was present on the CuNi coupons throughout the study. Visually, the amount of biofouling on the CuNi was much less than the stainless steels. The biofouling was also easier to clean

off of the CuNi coupons. Qualitative analysis of the material from all three metals revealed similar biofouling species (see taxonomic tables). The CuNi coupons were stained a dark brown early in the study. It is unknown what caused the staining, and unclear whether it promoted biofouling by inhibiting the CuNi from forming its protective anti-biofouling patina. The coupon open area occlusion caused by the CuNi biofouling was minimal (1%) for all sample intervals. Floating debris such as twigs and grasses were consistently present on all coupons.

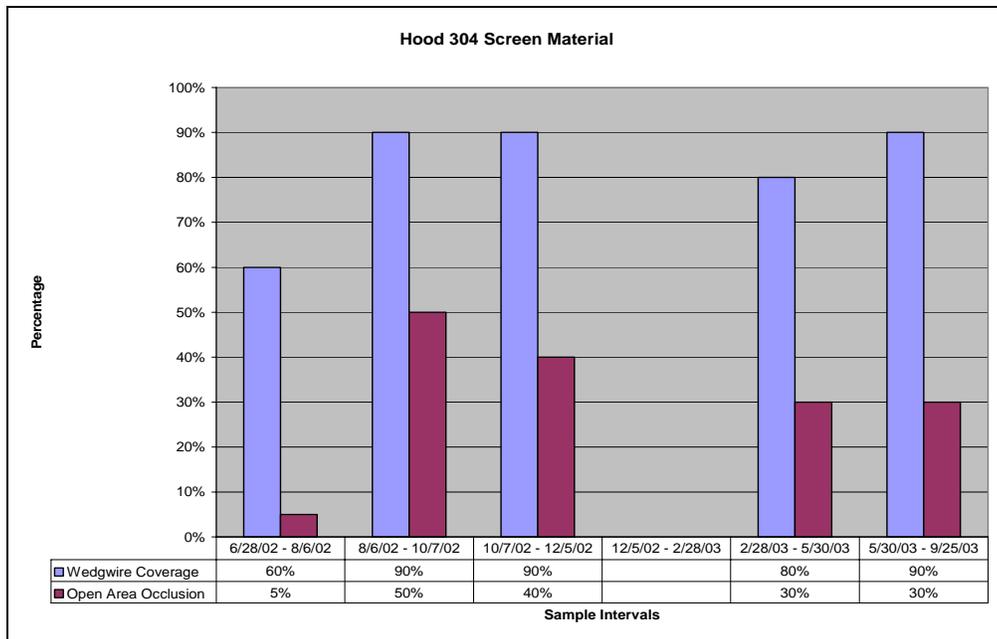
Chart 11. Hood Site – Percent coverage of Wedgwire surface face coverage and coupon open area occlusion for 304 stainless steel.

All sample intervals produced a high percentage of wedgewire surface face coverage on the 304 and 316 coupons. A total of three intervals produced 90% wedgewire surface face coverage on the 304 and 316 coupons (Charts 10-11). The gelatinous mixture of biofouling was very dense and blocked 50% of the 304 and 316 coupon open area for the interval of August 6, 2002 to October 7, 2002. The second highest percent (40%) of open area occlusion occurred during the interval of October, 7, 2002 through December 5, 2002. Floating debris such as grasses and twigs were consistently present on all coupons, including the CuNi coupons. The heavy silt load and how it accumulates on the screens can be seen in Figure 13. The coupons during the intervals that produced the lowest percent coverage had area with a thin layer of green algae and floating debris (twigs, grasses, leaves,). Floating debris was consistently present on all the coupons at this site. This is a site that had very high silt content, which is evident from the photos taken at the site that show heavy silt buildup on the coupons. The 304 and 316 coupons required moderate scrubbing with a nylon brush to remove the material.
