Chapter 1. Channel Volume Correction in DSM2-Qual Version 8.1

1.1 Introduction

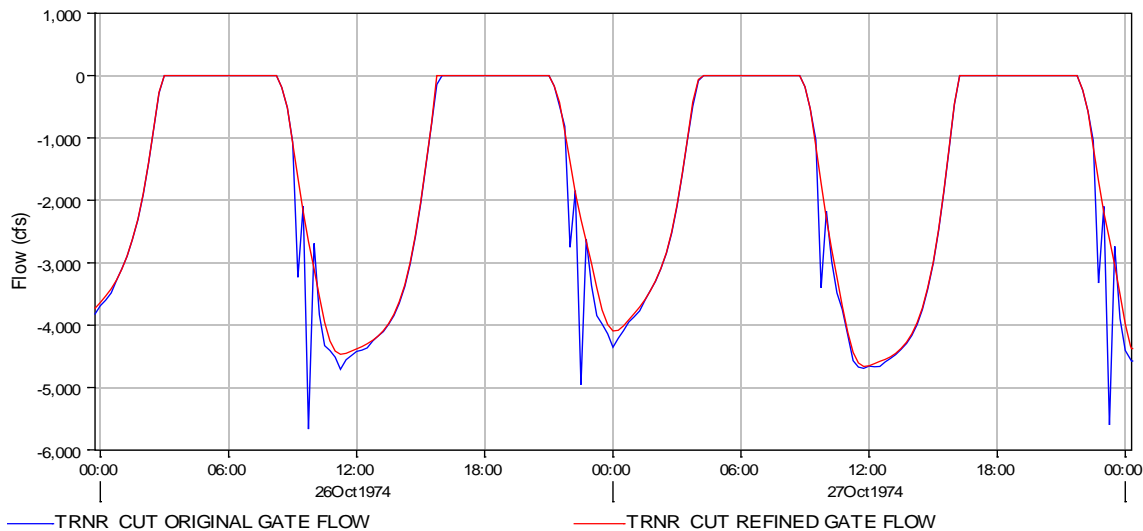
Figure 1-1 Simulated Flow at Turner Cut Gate before (blue) and after (red) Coefficient Change

1. Original setup: original Turner Cut gate with 15 minute time step for Hydro. Flow fluctuates at channel 172 are shown in Figure 1-1 (blue line). Volume balances in some channels (including 172) are bad and cause the 0 parcel problem in channel 172.

2. Refined setup: Turner Cut gate coefficients changed to 0.5 to remove flow fluctuations at channel 172 (red line in Figure 1-1). Volume balance is much better. Flow in the channel is not restricted by the gate coefficient change.

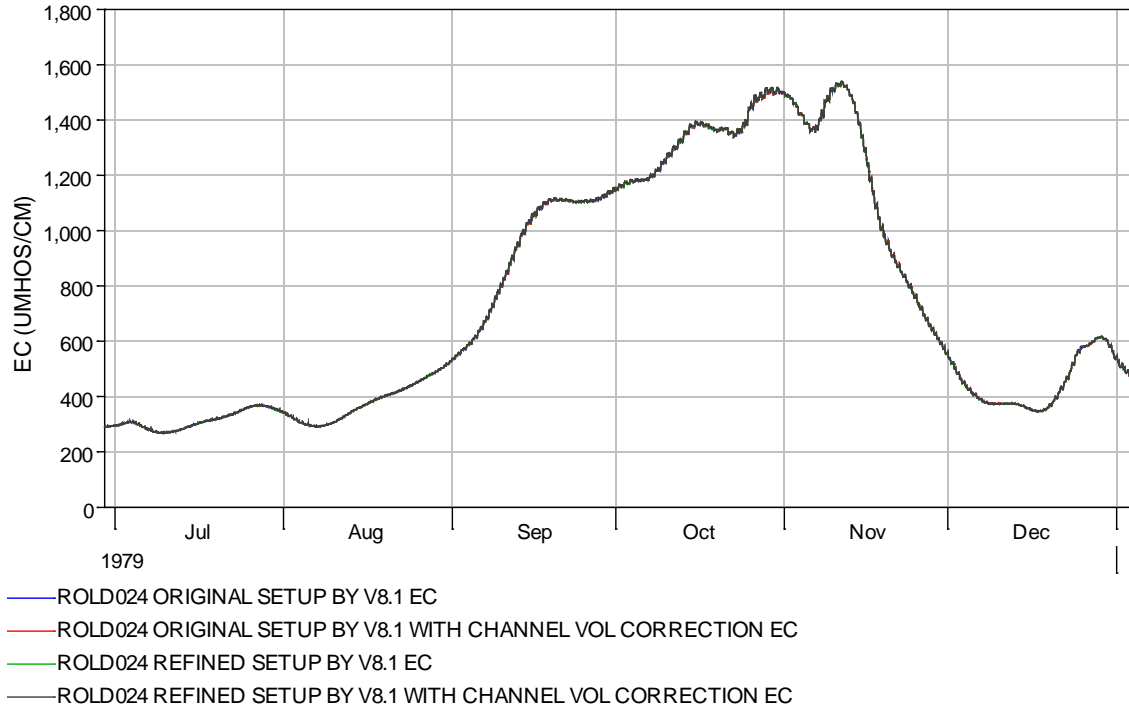
Figure 1-2 Simulated EC at Old River at Bacon Island (ROLD024)

For all four runs, electrical conductivity (EC) results were practically identical at key stations: RSAC081, RSAN007, RSAN018, ROLD024, and Clifton Court Forebay. The maximum difference between using the original v8.1 and v8.1 with volume correction was 0.05% at ROLD024 (Figure 1-2 and 1-3) with the original gate setup.

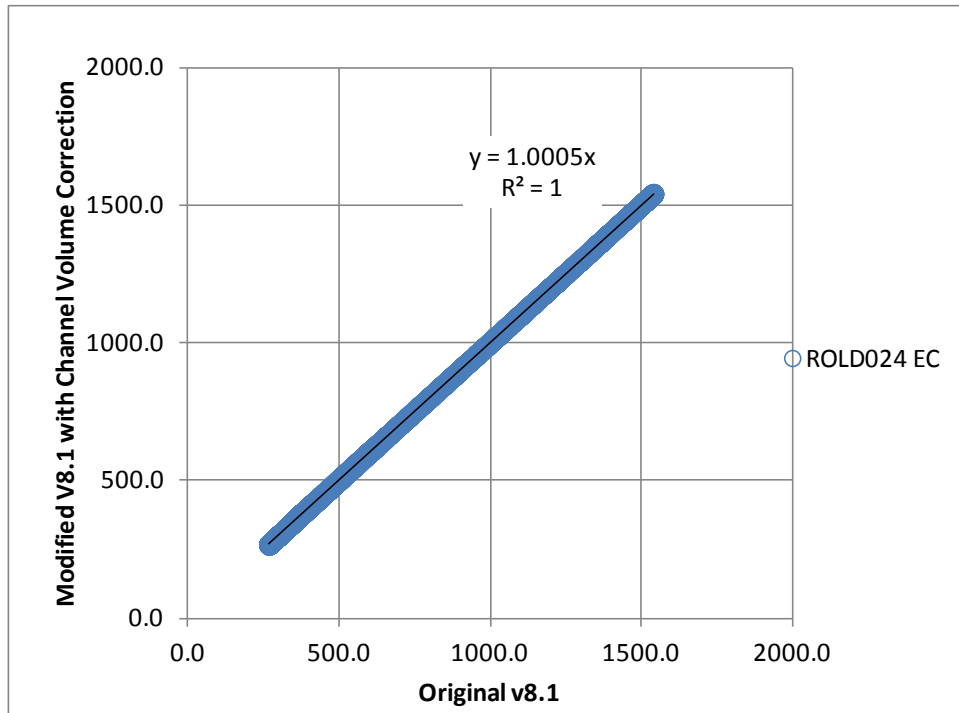
Figure 1-3 Regression Analysis of Simulated EC at Old River at Bacon Island (ROLD024)

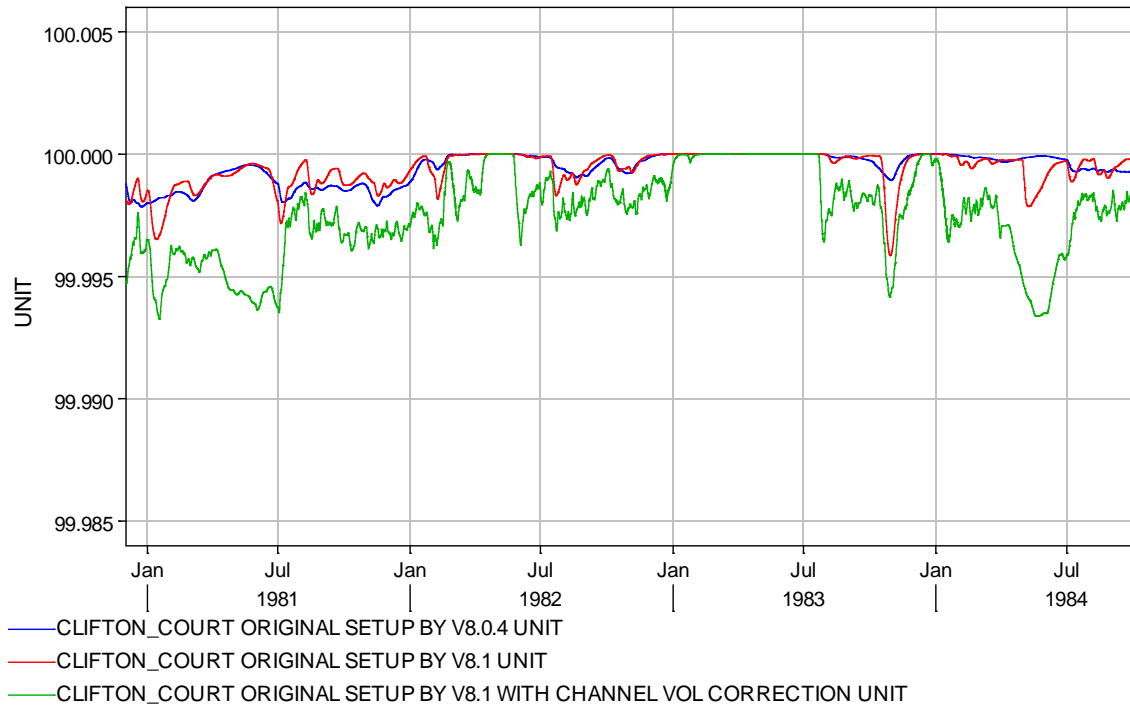
Figure 1-4 Volumetric Fingerprinting at Clifton Court Forebay with Original Setup

Volumetric fingerprinting² results are shown in Figures 1-4 and 1-5. With the original gate setup, the volume correction tended to make the volumetric fingerprinting slightly worse (i.e., the error was less than 0.01% as shown in Figure 1-4). The reason for such an error is because the volume correction is artificially adding (or removing) a small amount of water into a channel, which is not counted as an initial boundary condition. This additional amount of water would be spread out to other channels with time and cause some error in the volumetric fingerprinting. However, this error is quite negligible in this case.

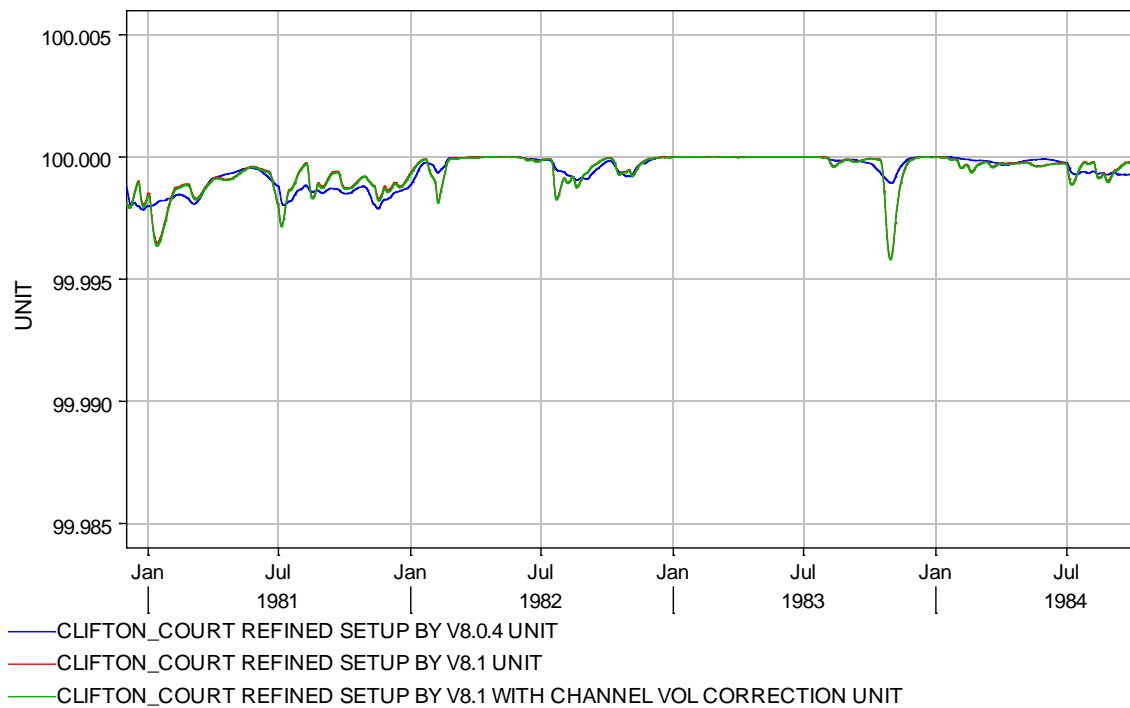
Figure 1-5 Volumetric Fingerprinting at Clifton Court Forebay with Gate Coefficients 0.5

With gate coefficients changed to 0.5, most flow fluctuations were eliminated and the mass balance was much improved. The volume correction did not cause any difference in volumetric fingerprinting results (see red and green lines overlapping in Figure 1-5). Also, we noticed in this figure that sometimes the total volume deviates from 100%. This is due to the fact that a very small amount of water is from the water originally in the Delta.
